SHEEPSCOT WATERSHED: RAPID STREAM ASSESSMENT

Bill Bennett, USFWS Gulf of Maine Coastal Program

Jen Noll, Maine Department of Marine Resources

Melissa Cote, Midcoast Conservancy

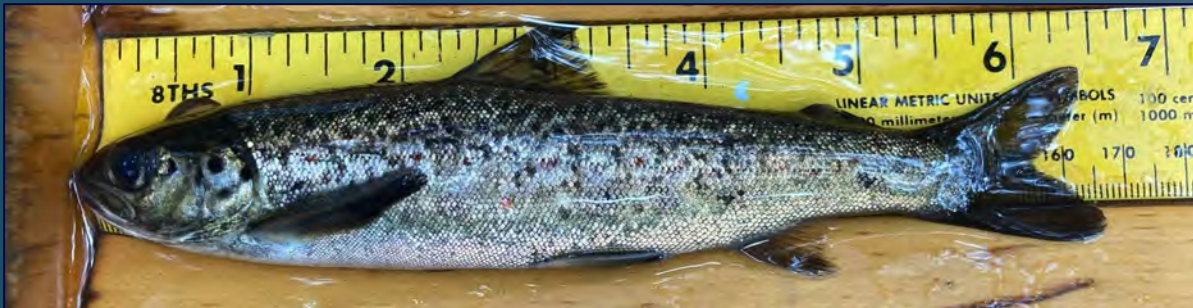
Sheepscot River Watershed Atlantic Salmon Habitat and Dams

- Located in Midcoast Maine
- 320 sq. miles, 58 miles long
- Supports a diverse community of habitats and at-risk species:
 - All 12 of Maine's native sea-run fish, including the southern-most genetically distinct population of Atlantic salmon (*Salmo salar*)
 - brook floater mussel
 - wild eastern brook trout
 - state listed turtles
 - migratory birds

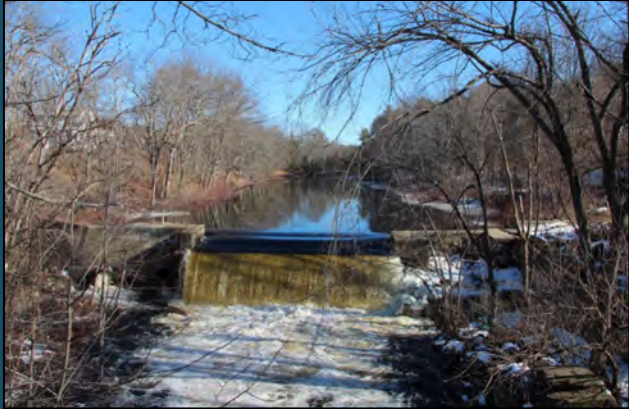
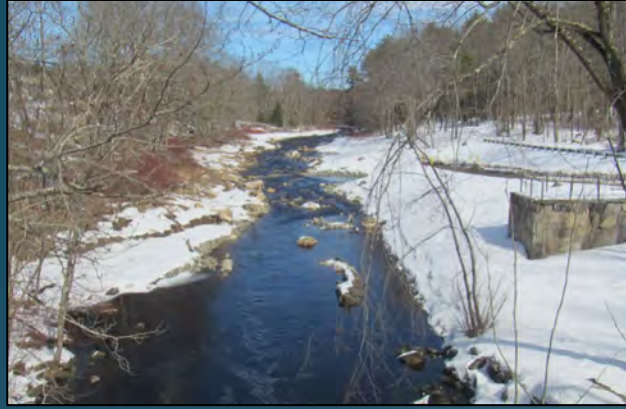
Photos from Inter-Fluve

- Two recent major dam removals:
 - Coopers Mills Dam in Whitefield (2018)
 - Head Tide Dam in Alna, partial removal (2019)

With major barriers removed, there is a greater need for in-stream habitat restoration.

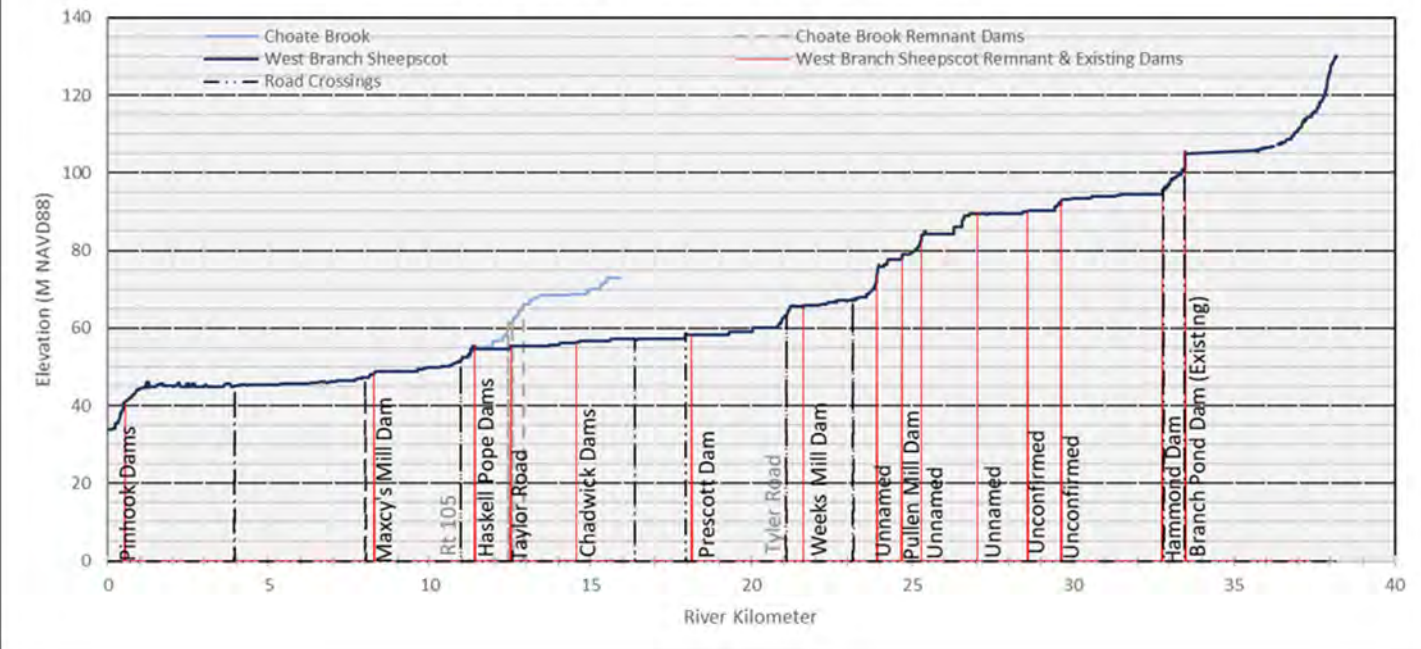
West Branch Sheepscot Longitudinal Profile

- **Stream Slope** – A longitudinal profile was generated, and stream slope calculated from the 2020 lidar in Spatial Analyst.
- Long low gradient segments caused by natural grade controls or remnant dams act as sediment sinks (Snyder et al. 2013).

Longitudinal profile with remnant dams and crossings overlaid

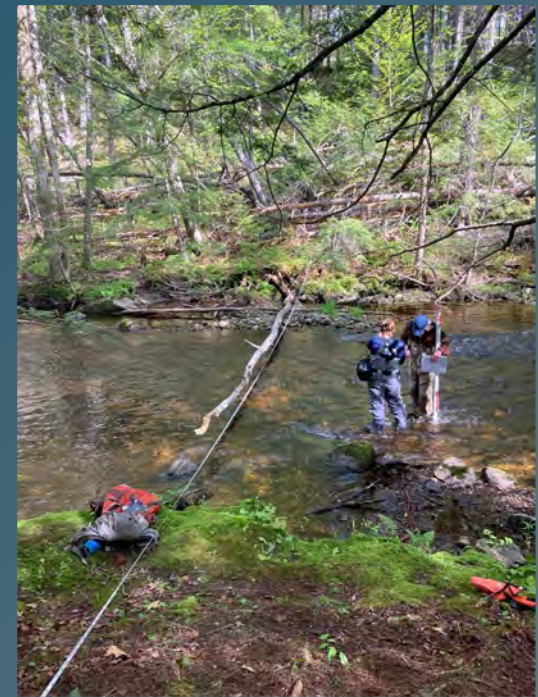
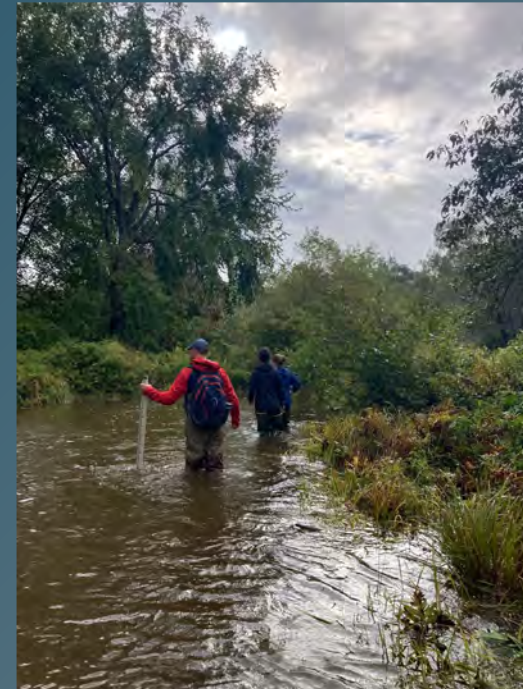
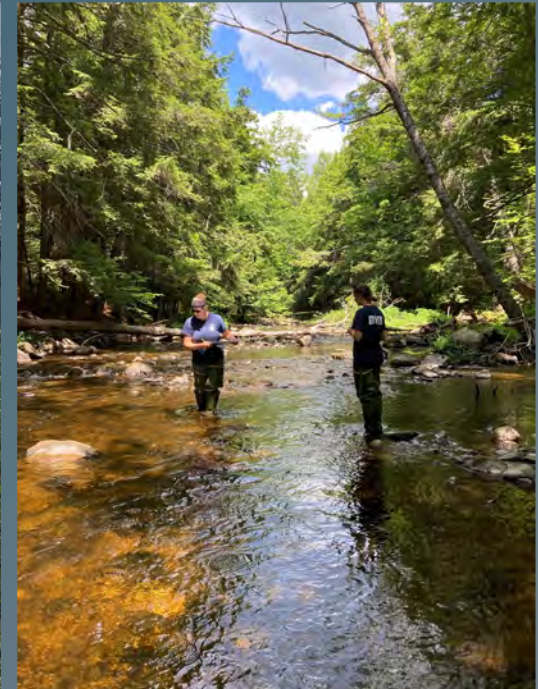
Elements Assessed in Assessment

- **Substrate**
- **Large wood**
- **Geomorphic Variables**
- **Pools**
- **Habitat Features**
- **Riparian condition**
- **Streambank condition**
- **Photographs**
- **Other notes of interest**

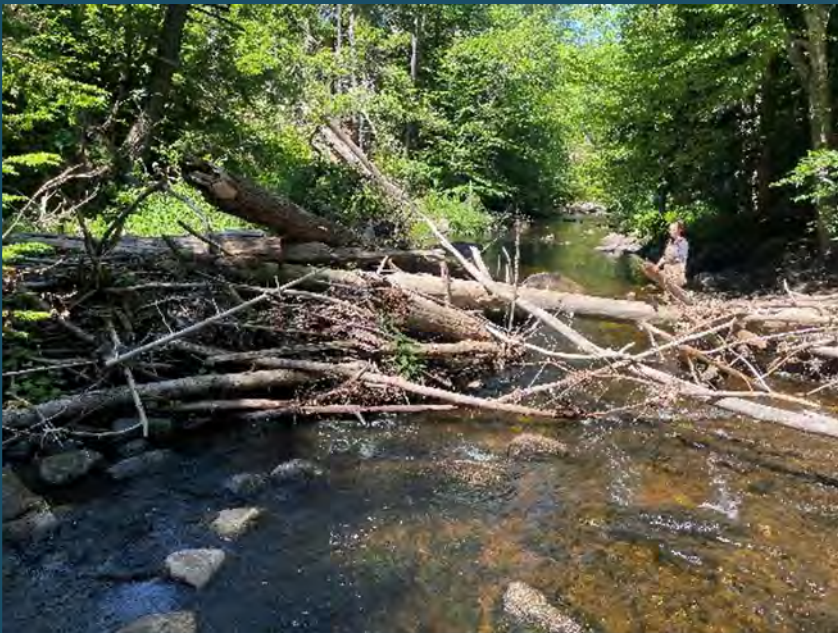
Palermo Preserve, Sheepscoot River

- Sites selected based upon DMR higher parr productivity at Palermo Preserve (Sheepscoot River) and Pullen Mill (West Branch Sheepscoot)
 - Reference reaches were intensively monitored to verify if high quality salmonid habitat
 - Water depth, temperature and dissolved oxygen levels were continuously monitored May - Nov 2022 for habitat suitability
 - Efishing data collected
 - Cross sections established with velocity measurements to generate discharge rating curve
 - Rapid Assessment completed in these two reaches first

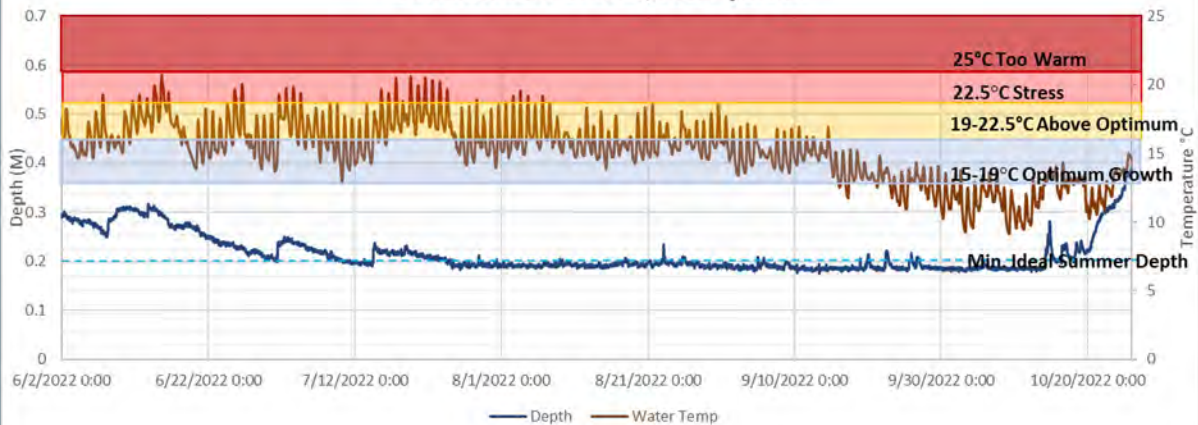
Palermo Preserve, Sheepscoot

Continuous Water Quality Monitoring of Potential Reference Reaches

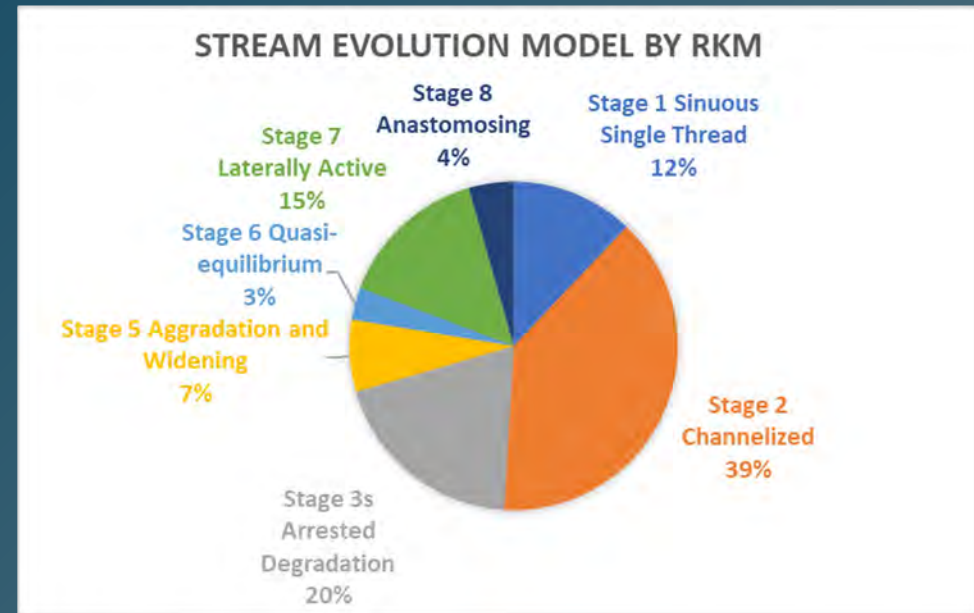
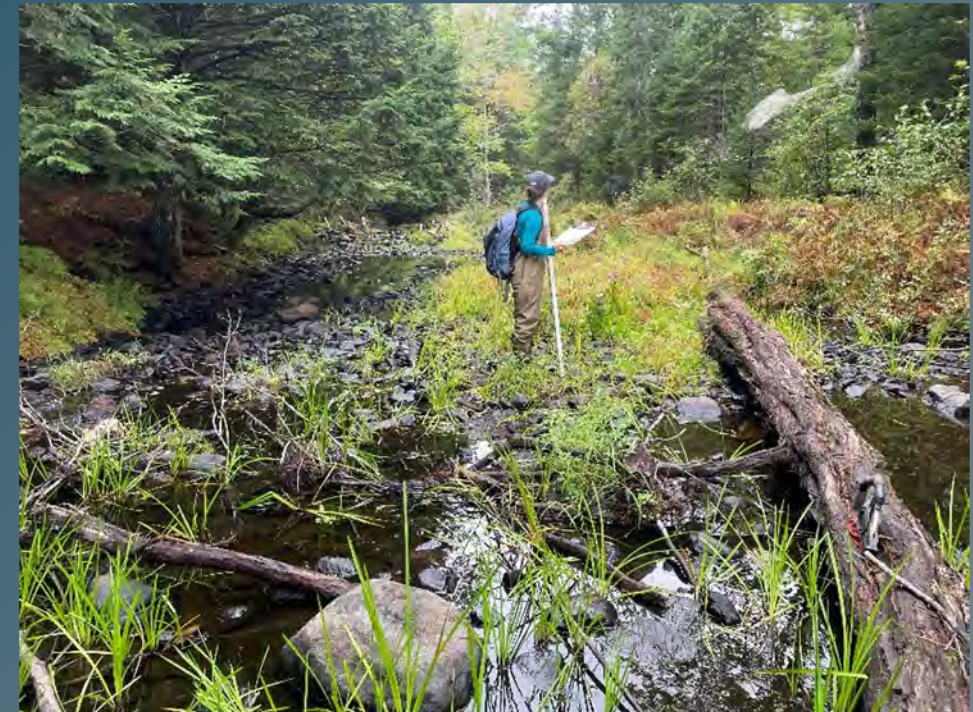
PALS installed in 2019 slowly shifting Stage 3s to 5

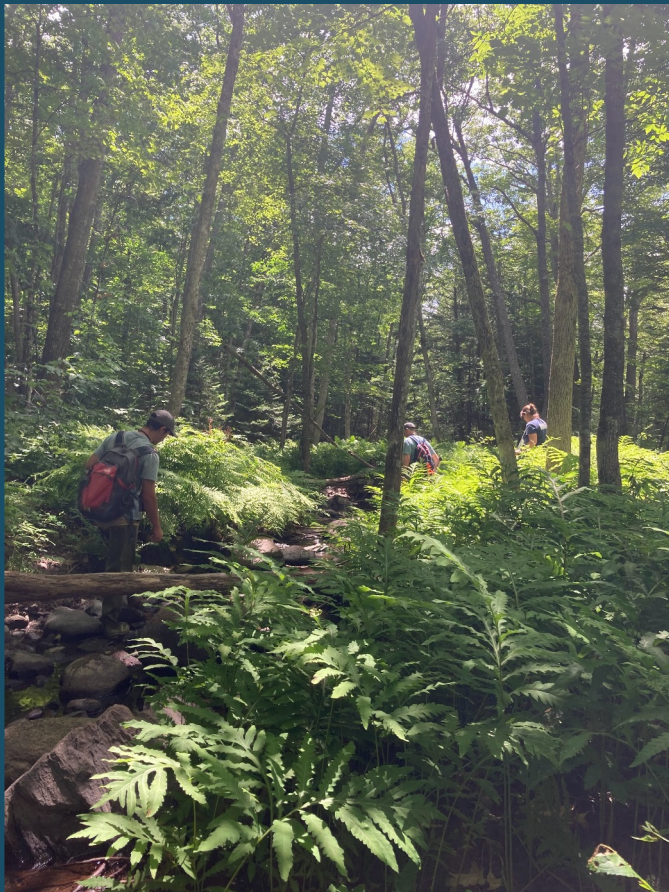
Sluceway in floodplain

- Channel is in an *Arrested Degradation (Stage 3s)* from historic mill dam operations
- *Geomorphic Grade Line* toolbox (by Powers et al. 2019) used to identify level of stream incision

Looking Downstream with sluceway on River Right

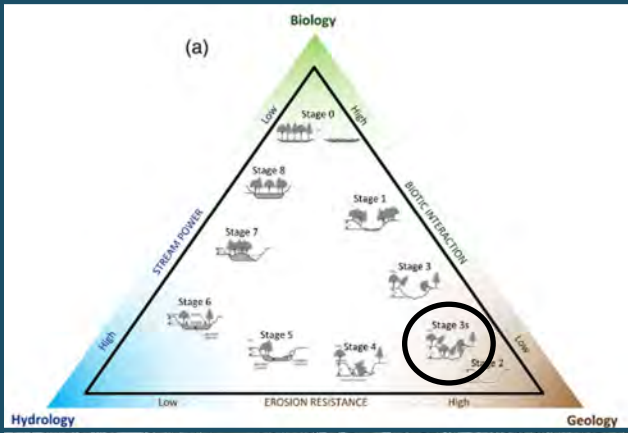
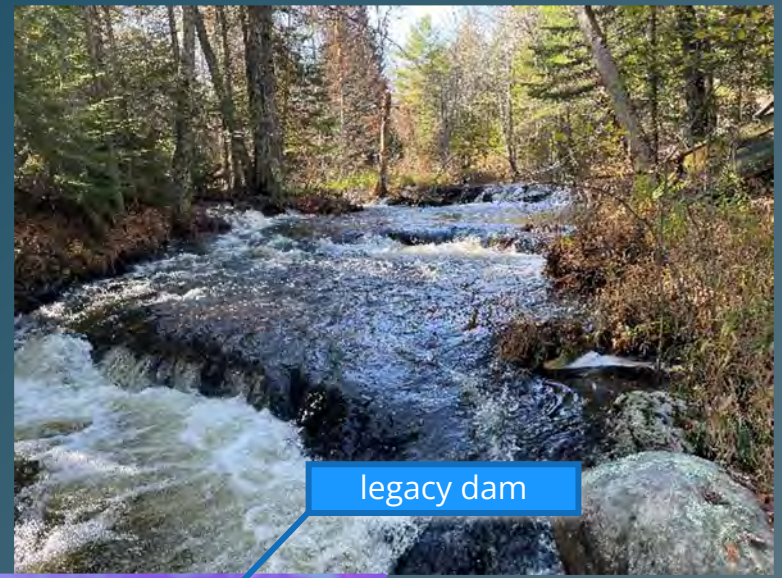
UPPER WEST BRANCH SHEEPSCOT

- *Upstream channel is impounded*
- *Downstream channel is in a state of Arrested Degradation (Stage 3s)*

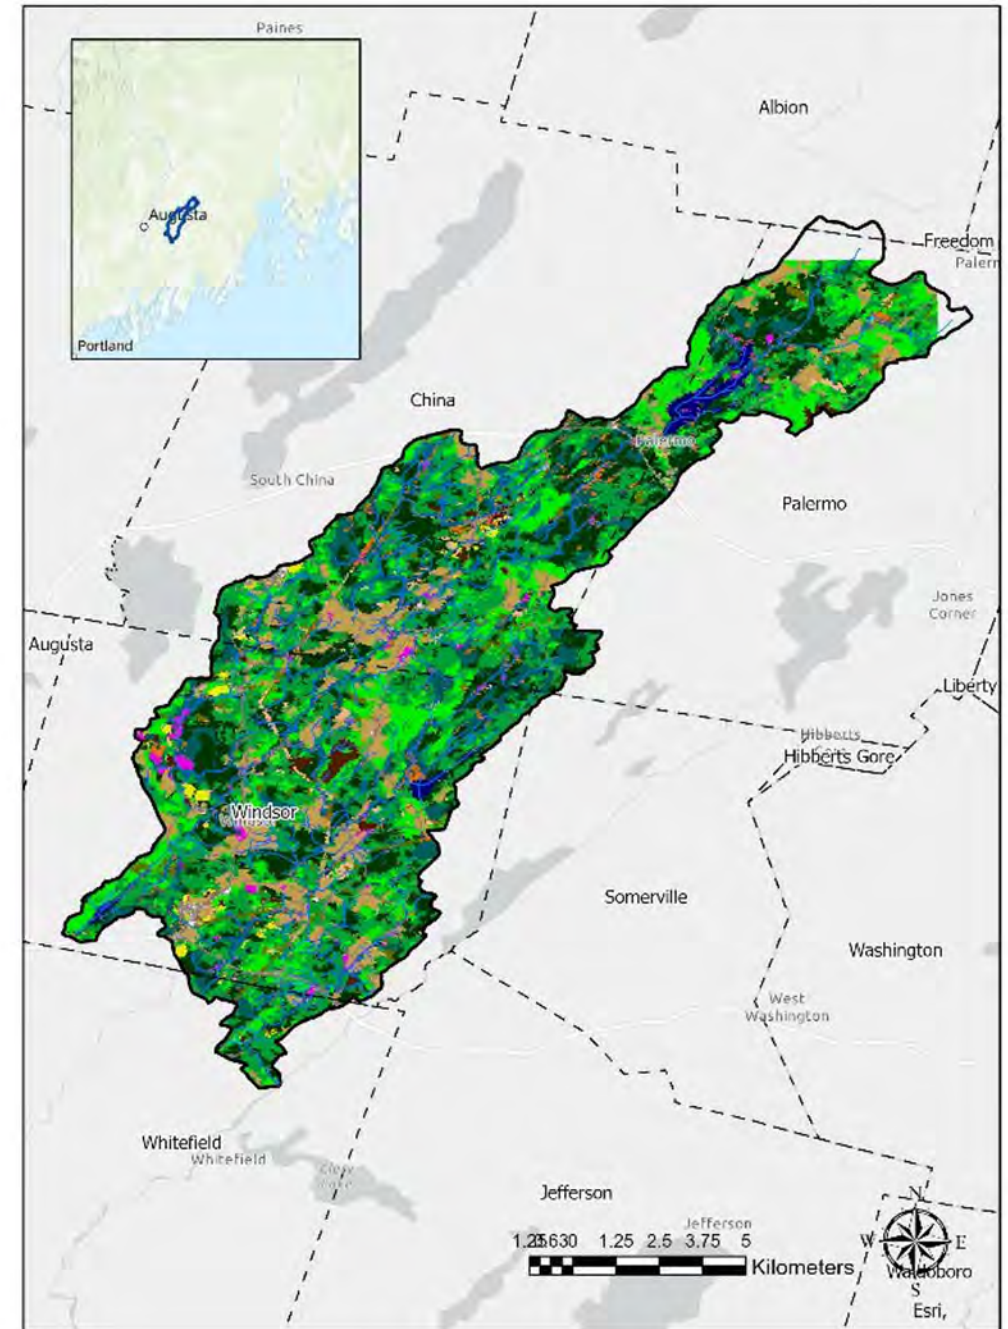
- Tributary of the Sheepscot River
- ~ 25 miles long, 50 sq. mile drainage area
- Most productive salmon habitat in the Sheepscot
- Land use:
 - natural land cover (86%)
 - 1% Impervious Cover (NOAA OCM 2022)
- Geology predominantly glacial till and glaciomarine deposits (Maine Geological Survey)
