# Design of the Crossroads Landfill over Presumpscot Formation

## ABSTRACT

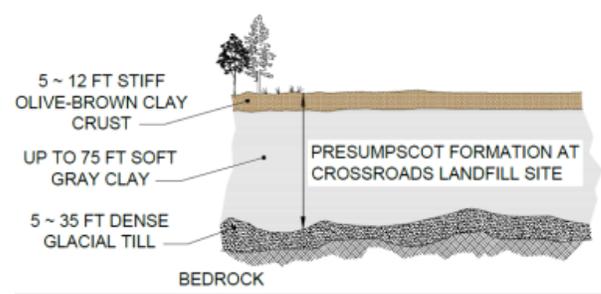
Figure 1. Site stratigraphy in the area of the landfill.

can be divided into an upper olive-brown layer and an underlying gray stratum. The subsurface stratigraphy is shown in Figure 1, and is summarized as follows (from top to bottom).

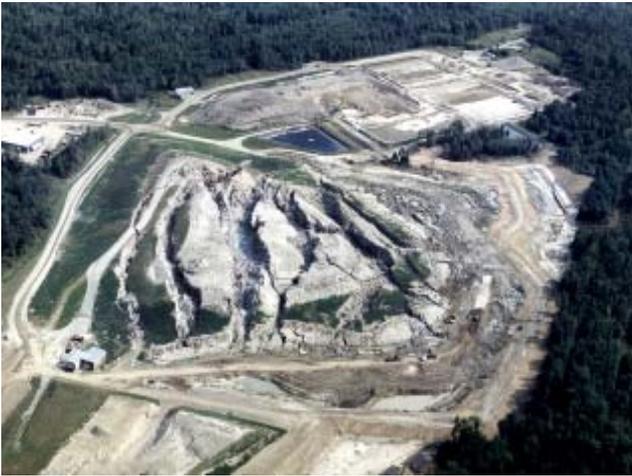
Figure 2a. Aerial view of 1989 landslide caused by retrogressive failure of the Presumpscot Clay foundation under the landfill (waste moved from left to right in photographs).

The slide was a classic retrogressive failure [Richardson & Reynolds, 1990]. A small slice of waste near the toe moved first, which by itself wouldn't have been catastrophic. But this reduction in the toe buttress triggered movement of a bigger adjacent slice of the landfill. This caused movement of yet another slice, etc. resulting in a massive landslide. The retrogressive failure mechanism can be discerned from the chunky appearance of the MSW pile after the failure shown in Figures 2a and 2b.

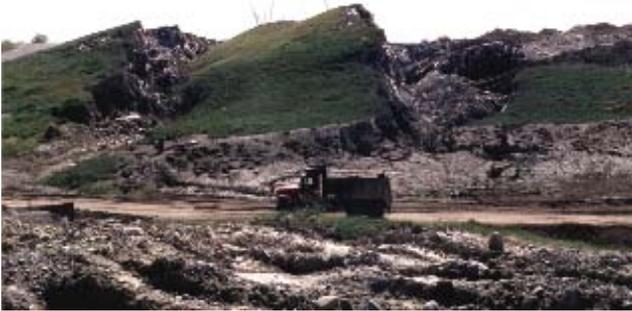
Figure 2b. Side view clearly showing the retrogressive failure mechanism.

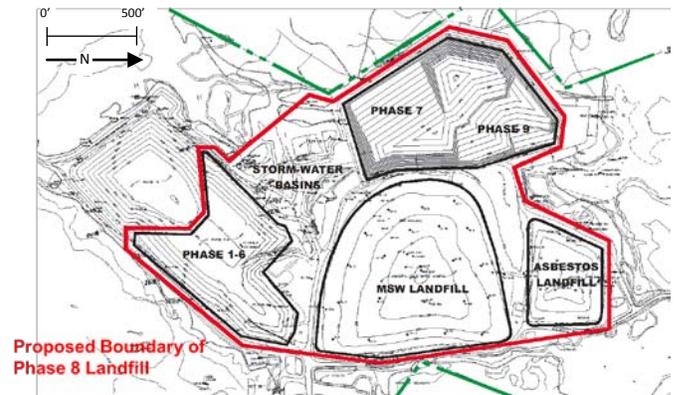
Figure 3a. Plan view of MSW Landfill and surrounding waste disposal units constructed and filled after 1989 slide.

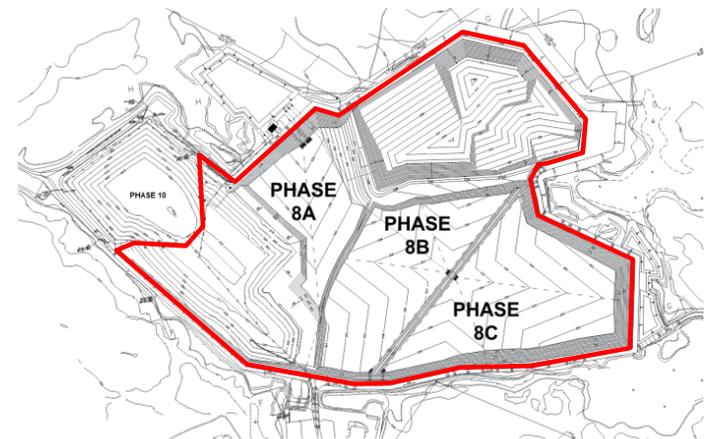
Figure 3b. Liner grades of proposed Phase 8 landfill unit.

To construct the lined landfill cells shown in Figure 3b, the Phase 8A cell had to be constructed first, followed by excavation/relocation of the waste from the southern half of the MSW pile into Phase 8A. This allowed construction of Phase 8B, subsequent excavation/relocation of the northern half of the MSW pile into Phase 8B, and then construction of Phase 8C.

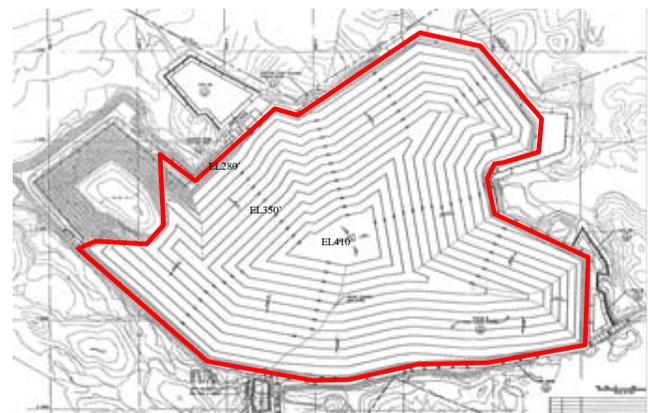
Figure 3c. Proposed Phase 8 waste grades.

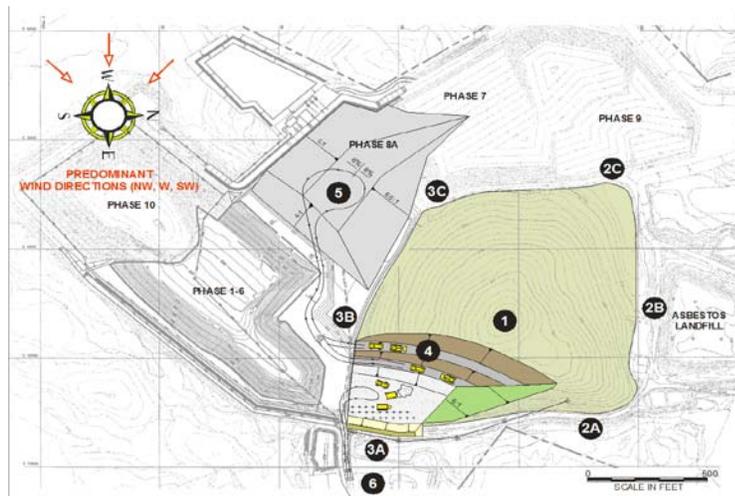
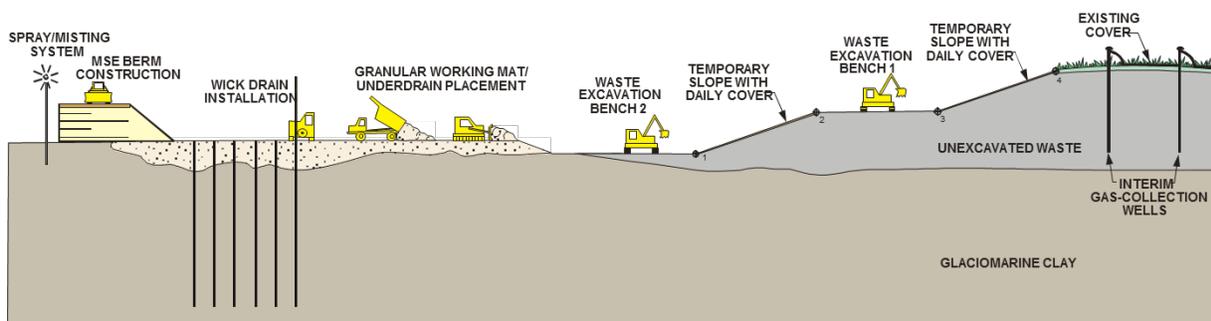
Figures 4a (above) and 4b (below). Illustration of waste relocation from unlined MSW Landfill into lined cells.

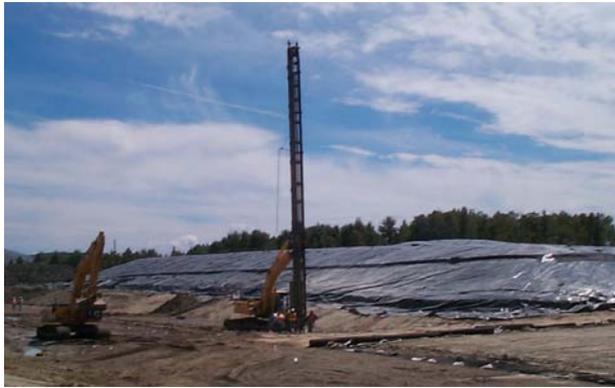
Figure 5a. Rig used to install prefabricated vertical (wick) drains.

The proposed Phase 8 design required confident engineering reliance on the increase in strength that would occur in the Presumpscot Clay as it consolidates. To accelerate this process, more than 75,000 PVDs were installed prior to constructing the liners in the new Phase 8A, 8B, and 8C cells (see Figures 5a and 5b).

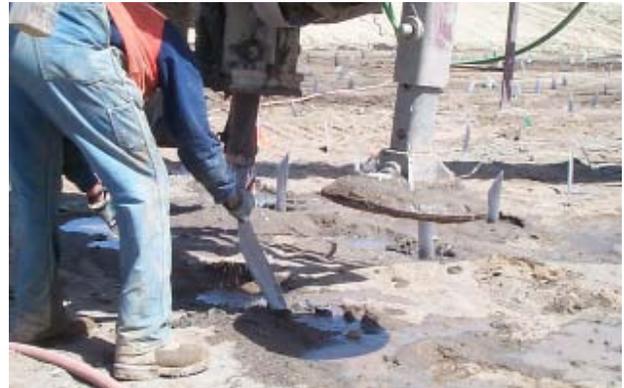
Figure 5b. Tops of prefabricated vertical drains (PVDs) being cut off at the elevation of drainage blanket (underdrain) layer during installation

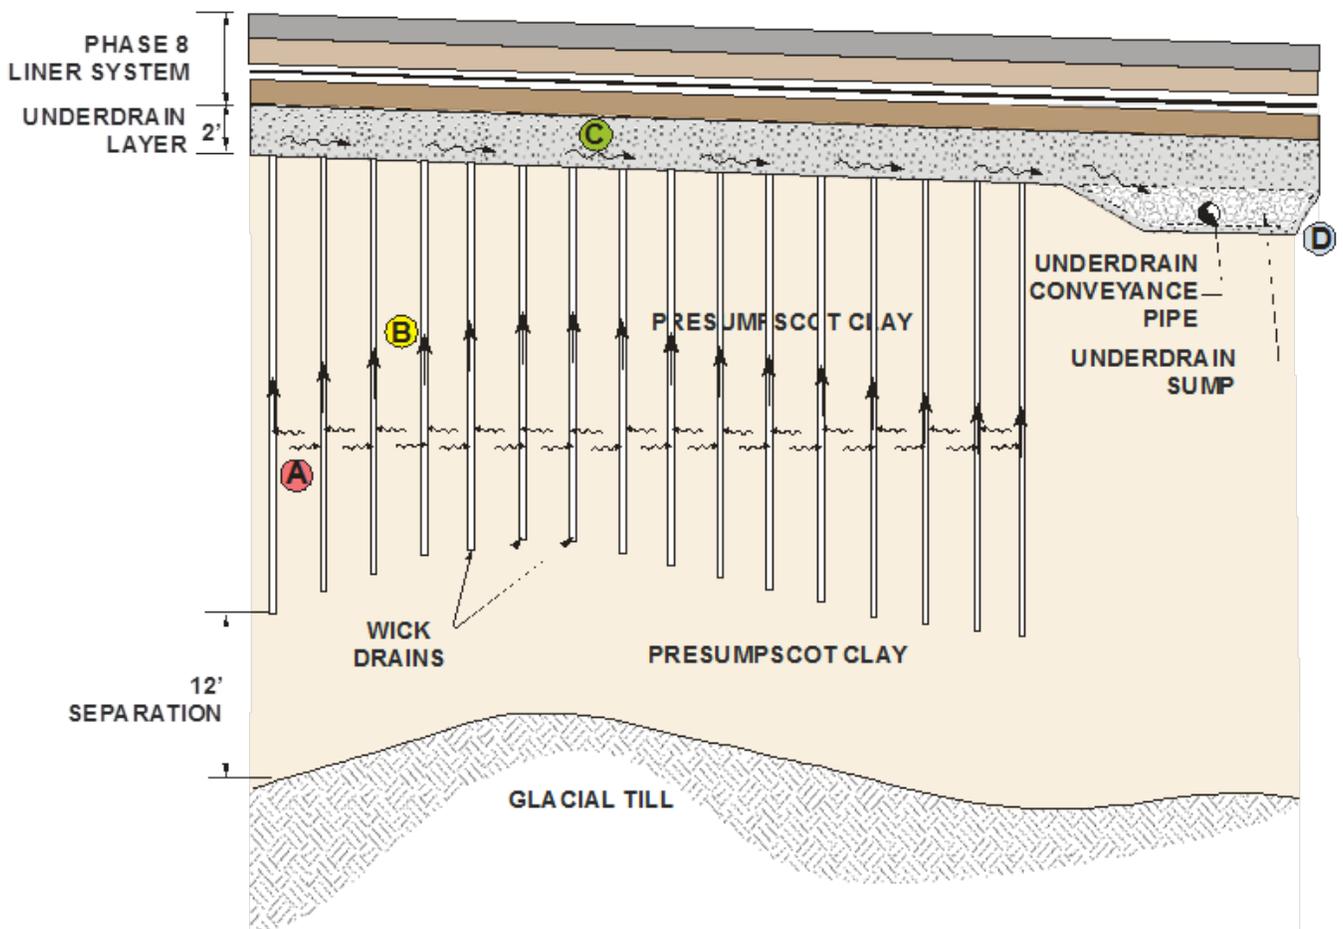
Figure 6. Profile illustration of prefabricated vertical drains (wick drains) and blanket underdrain beneath landfill liner system

The PVDs were installed at a horizontal spacing of 5–10 ft on center, and to depths ranging from 20 ft to 75 ft such that the bottoms of the PVDs extended no closer than 12 ft above the underlying Glacial Till. The 12-ft vertical separation zone was maintained as a hydraulic barrier over the till, thereby not allowing upward migration of water from the till aquifer into the PVDs nor the downward migration of potentially impacted groundwater from the area of the previously unlined MSW pile into the till aquifer (see Figure 6). The PVDs were also installed diagonally outward near the edge of landfill prior to construction of the perimeter berms to facilitate rapid strength gain in the Presumpscot Clay foundation over a larger lateral area.

A drainage blanket (underdrain) into which the top of the PVDs terminate was installed prior to and directly beneath the Phase 8A, 8B, and 8C liners. The underdrain consisted of a minimum 2-ft thick layer of clean sand ( $k \geq 5 \times 10^{-3}$  cm/s). A network of perforated outlet pipes in the

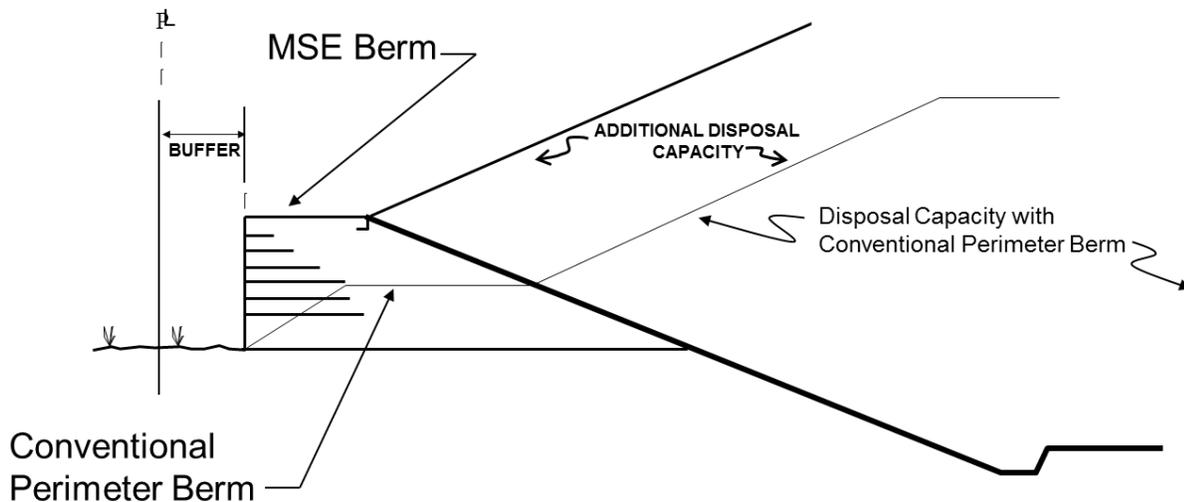
Figure 7. Cross section showing additional disposal capacity provided by Mechanically Stabilized Earth perimeter berm.

In this pursuit, mechanically stabilized earth (sometimes referred to as reinforced soil) berms were designed around much of the perimeter which, as illustrated in Figure 7, greatly increased the disposal capacity of Phase 8. The average height of the MSE perimeter berms was 20 ft, which provided over 500,000 yd<sup>3</sup> of additional disposal capacity compared to what would have been provided for roughly the same lined footprint using conventional berms.

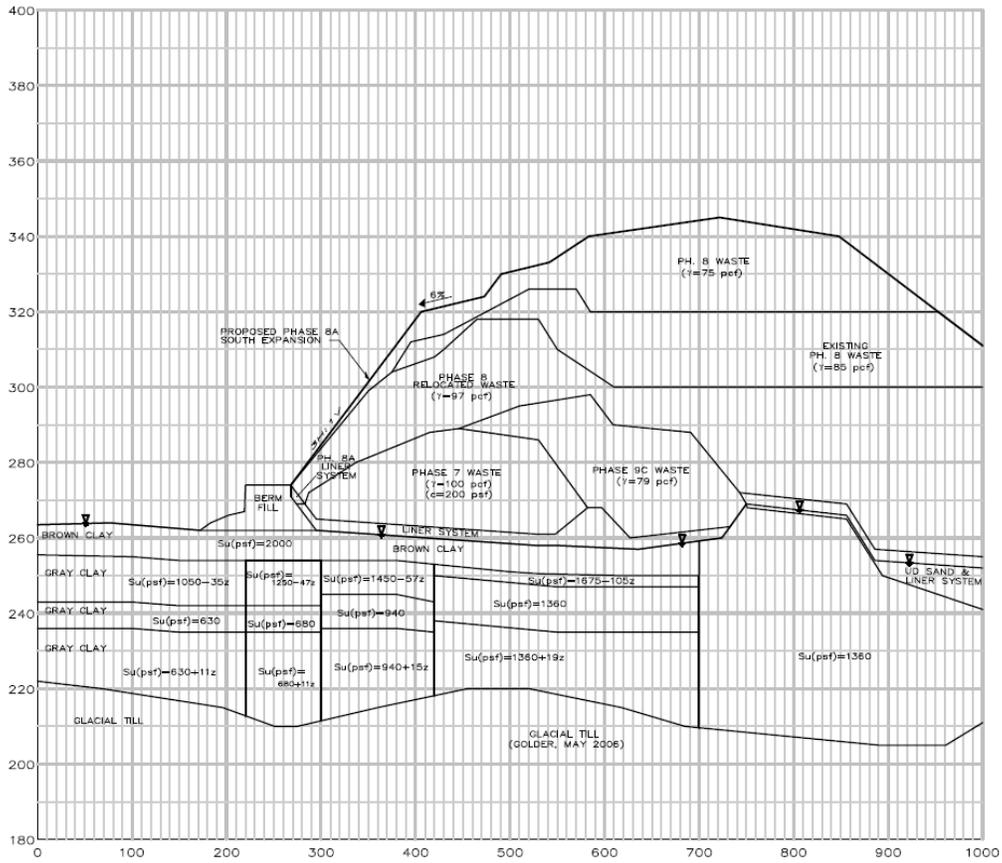
Figure 8a. Subsurface stratigraphy for one stability section of Phase 8.

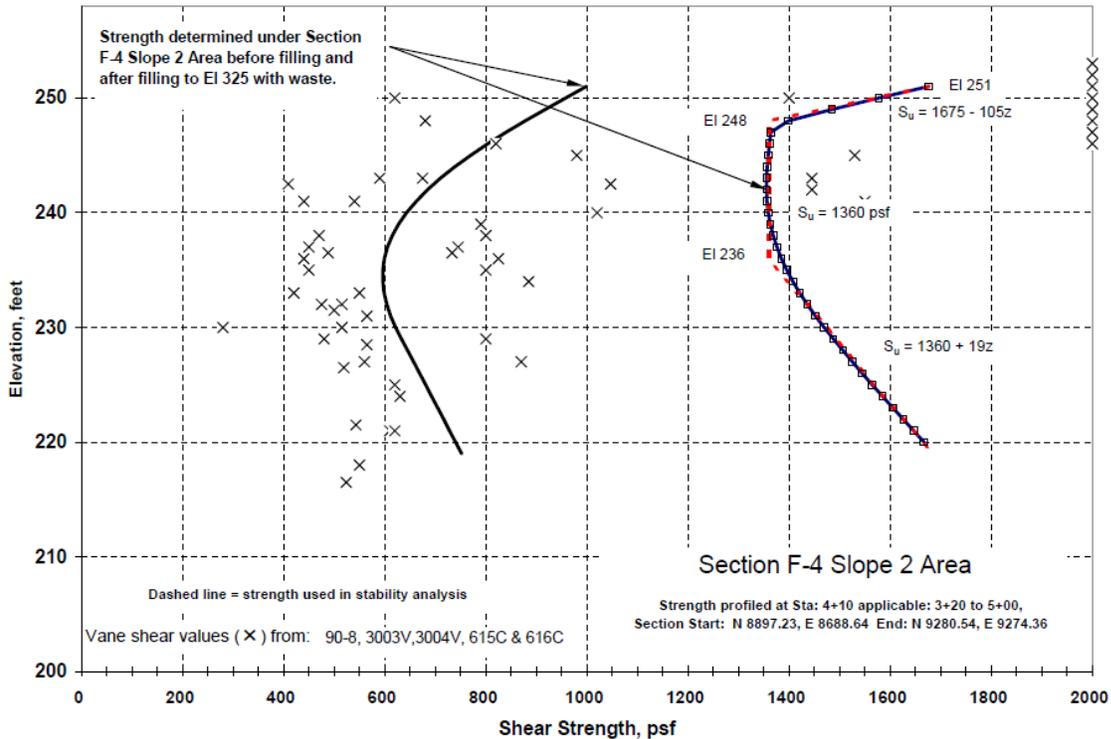
Figure 8b. Strength of Presumpscot Clay as a function of depth and stress history at section shown in Figure 8a.

reconsolidation of the Shelby tube samples to the virgin state (i.e. the preconsolidation pressure) then unloading to the desired overconsolidation stress and testing in direct simple shear. The results were used to develop shear strength profiles for the underlying gray clay. A profile showing the subsurface stratigraphy in one area of the Site is shown in Figure 8a and the accompanying soil strength profile is shown in Figure 8b. (See Reynolds Companion Paper for more details of how the shear strength profiles were developed).

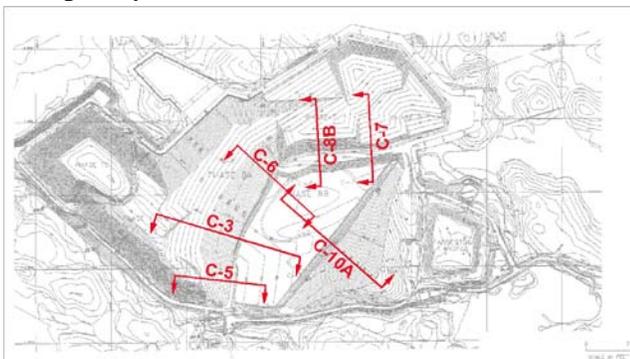
Figure 9. Locations of critical stability sections used to establish and evaluate waste excavation/relocation configurations that would be allowed during construction

As previously mentioned, construction of the lined cells for Phase 8 required incremental (sequential) cell construction and waste relocation from the unlined MSW Landfill. Since the 1989 failure had resulted in waste blocks that had shifted (rotated) down as they moved laterally, the excavation of waste had to be carefully pre-engineered to ensure the surrounding waste slopes would be stable during the excavation and relocation activities. This involved design and analyses of many excavation configurations (see Figure 9) to ensure:

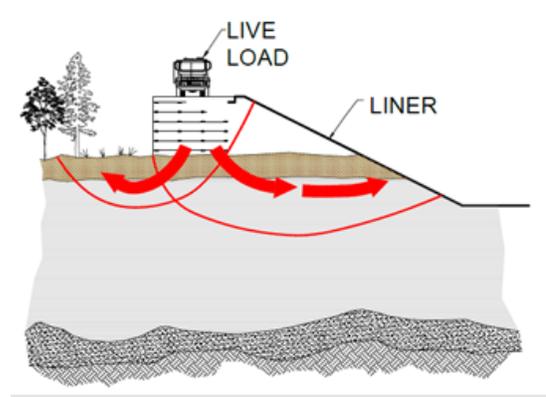
Figure 10a. Inward and outward traditional bearing capacity failure modes analyzed for the MSE berm at designated locations around the Phase 8 perimeter.

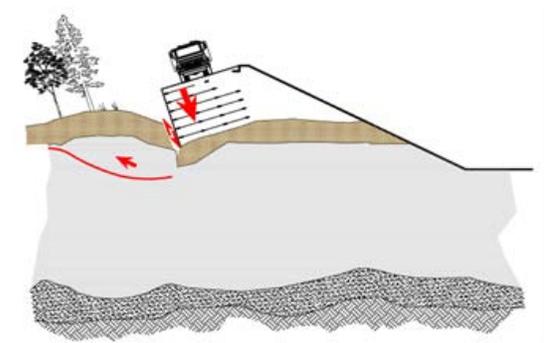
Figure 10b. Punching shear bearing capacity failure mode analyzed for the MSE berm at designated locations around the Phase 8 perimeter.

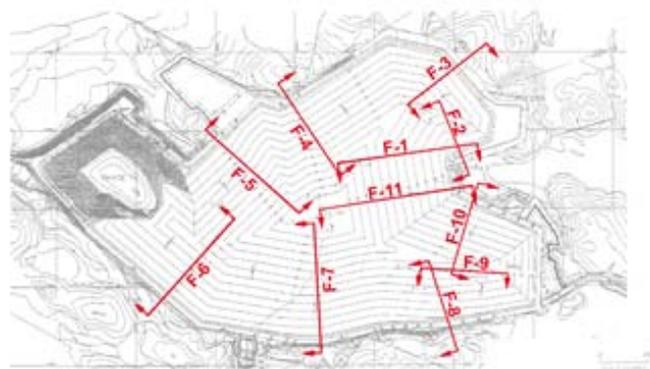
Figure 11. Phase 8 waste-configuration design and locations of critical sections for stability analyses.

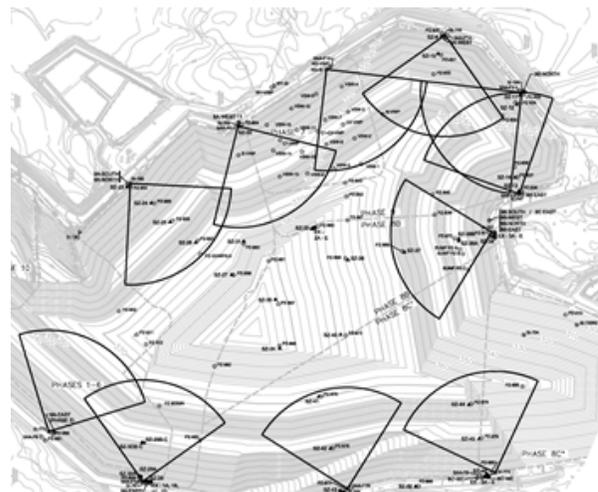
Figure 12. Zones of influence for monitoring stability using instrumentation during waste placement.

A stability monitoring plan (SMP) was developed to guide the acquisition and interpretation of the data in monitoring the stability of the landfill. The SMP defines the zones of influence in which the Presumpscot Clay, and therefore the instrumentation in any given area, could be affected by waste placement in that zone. The SMP then prescribes the frequency that data from the instrumentation must be obtained when waste is being placed within each zone of influence illustrated in Figure 12.

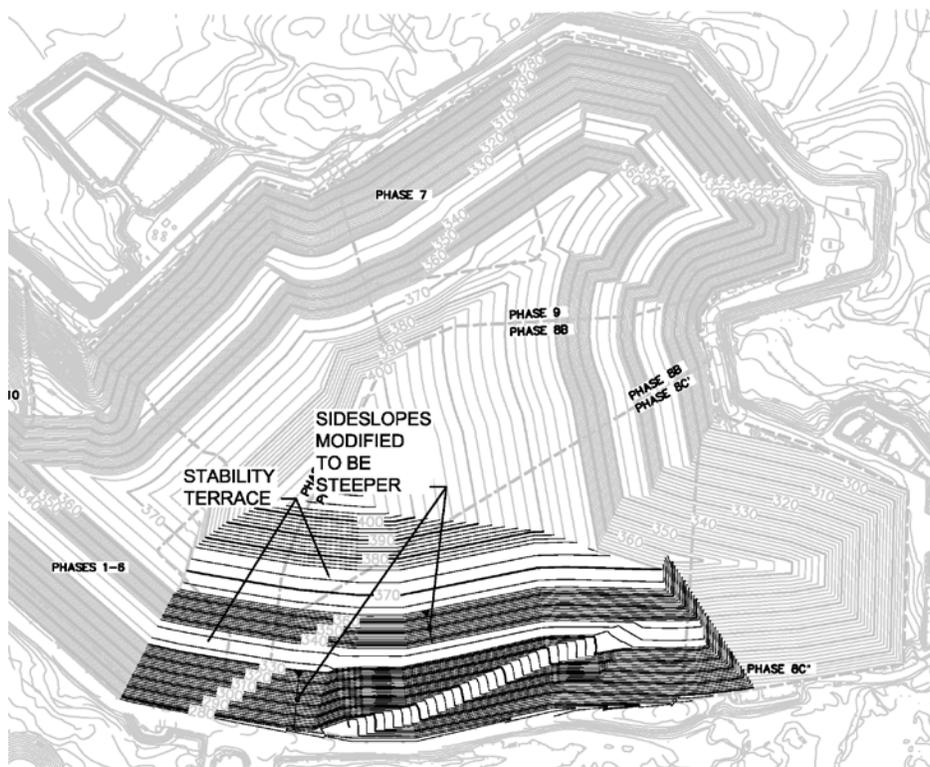
Figure 13. Example of sideslope modifications using steeper sideslopes and stability terraces.
