25-years of loading an old Presumpscot Fm landslide: a case history

R. T. Reynolds, PE, DGE

ABSTRACT: This case history discusses why a landslide occurred when about 70 feet of fill were placed on a like thickness of the Presumpscot Formation. The case history then summarizes steps that have been taken at the site to avoid another slide, while permitting a new waste pile to grow to over 100 feet in height. Important examples of some of these steps are discussed in detail, including: how typical field and laboratory testing techniques can be modified to yield better data, how much undrained shear strain of the Presumpscot Formation is too much, how long-term drained strain will strengthen the clay, what less than obvious precautions, should be taken to avoid landslides when placing many stages of load on the Presumpscot Formation, and how automated geotechnical data collection systems can help maintain stable slopes, when manually collected data is economically unfeasible.

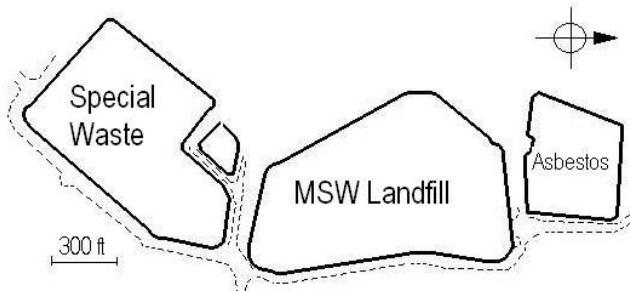
Figure 1 – Site plan of landfill at Norridgewock, Maine before the 16 August 1989 MSW Landslide. The small polygon next to the Ash/Sludge (Special Waste) Landfill was a leachate storage pond.

The scopes of these tasks are summarized below along with some of the more important findings. It should be noted that near the end of the landslide assessment phase of the work, Waste Management Disposal Services of Maine (WMDSM) purchased the entire site from CWS and renamed it their Crossroads Landfill site. WMDSM has subsequently and successfully planned, permitted, constructed and operated additional landfill units on the site, first adjacent to the slide area, then completely away from the slide area, and finally over top of the three landfill units shown in Figure 1.

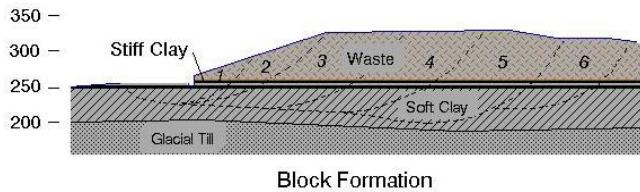
Figure 2 – MSW waste and clay blocks before breaking apart in the 1989 MSW Landslide.

The availability of air photos and topographic maps before and after the MSW Landslide proved to be invaluable in the sketching of Figures 2 and 3. A few borings were drilled through the old waste pile to search for remolded clay. The technique of reconstructing the original landfill prior to the landslide, used by H.B. Seed, et. al. (1975) in their analysis of the Lower San Fernando Valley Dam failure was used to substantiate the depth of the sliding surface. As Seed, et. al. (1975) did, Figures 2 and 3 were drawn to scale. They are not merely artistic renditions of the slide. An excavation and

relocation of the MSW years later verified the location of the shear surface shown in Figure 3.

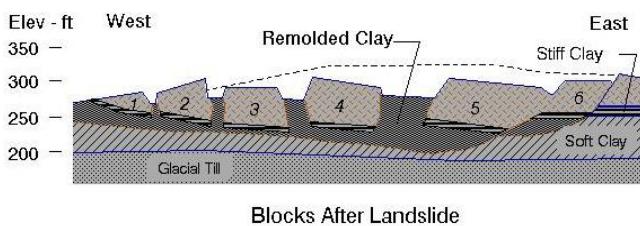
Figure 3 – MSW waste blocks “floating” in remolded and intact clay after the 1989 MSW Landslide. Enlarged versions of Figures 2 and 3 are included in Attachment A.

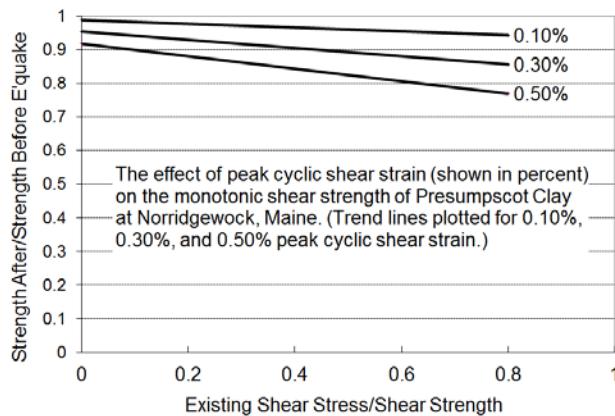
Figure 4 - Monotonic shear strength loss as a function of the peak cyclic shear strain and existing shear stress ratio (from Reynolds, 1995)

Reynolds (1995) presents details of this work. In summary, the plot for estimating the strength loss is provided in Figure 4. The steps that are followed are listed below Figure 4.

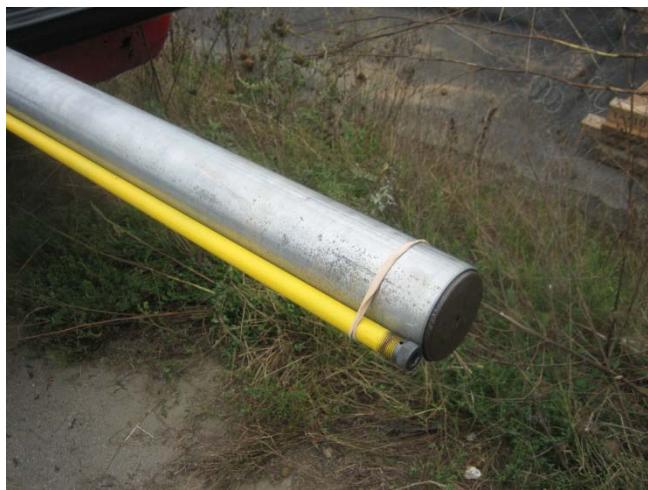
Figure 5 – Jet rod with side discharge tip attached to bottom of Acker GUS sampler. Once the sampler is resting on the bottom of the borehole, the jet rod is held up so it does not advance when the Shelby tube is hydraulically pushed.

There have been various tools developed to break the suction at the bottom of the sampler, e.g. the Laval sampler. We chose to make our own tool with a very small diameter jet drill rod that would just fit between the fixed piston sampler and the 4" diameter casing. Figures 5 and 6 illustrate the suction breaker jet rod.

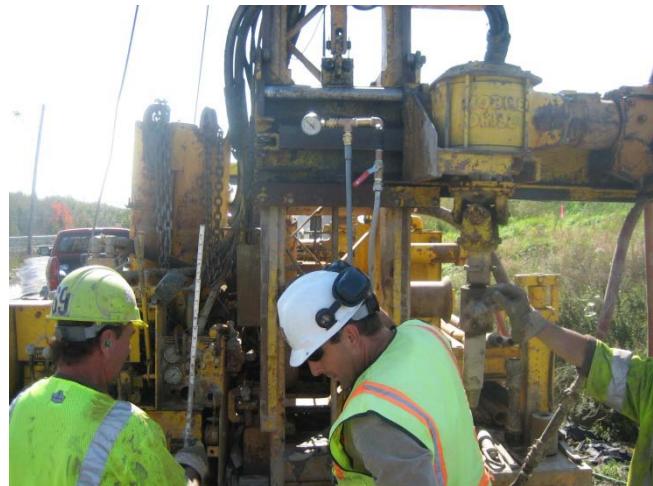
Figure 6 – Geologist, Bob Estes, using an up-down and rotating motion on the jet rod to wash a small hole from the bottom of the borehole to the tip of the GUS sampler.

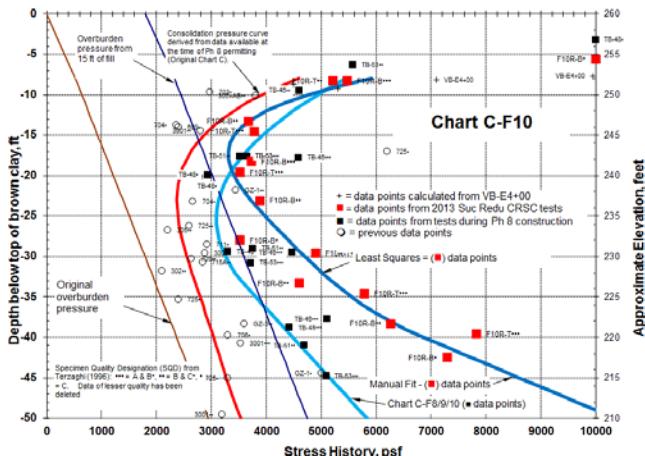
Figure 7- Stress history or preconsolidation stresses vs. depth for specimen obtained before 1998 (red curve), between 2000 and 2005 (light blue curve) and in 2013 (dark blue curve). Enlarged versions of Figures 7, 8, and 9 are included in Attachment A.

Figure 7 provides a comparison of three preconsolidation pressure curves for Presumpscot Formation specimens from essentially the same location. The curves were based on the data available when they were drawn. All three curves used least-squares curve fitting for their respective data. The red curve was drawn, based on data collected through about 1998 – the data points are shown in small circles. The sampling and testing up to 1998 basically comprised conventional push Shelby tubes and oedometer tests.

The light blue curve is based on data collected between about 2000 and 2005. The data points from which the light blue curve was drawn are shown with black squares. Those data are from CRSC (constant rate of strain consolidation) tests on tubes collected with the Acker GUS sampler, where the specimens were x-rayed. The dark blue curve is based on data collected in 2013 using all of the improvements in the sampling and specimen selection discussed above. These data also come from CRSC testing.

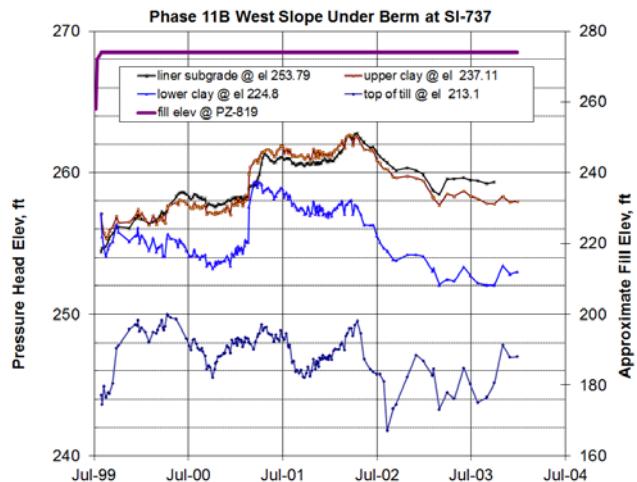
Figure 8 – PZ 819 located under the stability berm at the toe of the waste slope.

In late 2003, the author was having a conversation with the independent geotechnical reviewer, Tony Hersh of S W Cole, Inc, when he asked why we saw a buildup in pore pressure at the toe of a landfill in early 2001. That was long after the stability berm fill had been placed at this location (in 1999). Figure 8 shows the pore pressure curves he was asking about. The burgundy curve (horizontal line after 1999) indicates the fill level over the piezometers at this location.

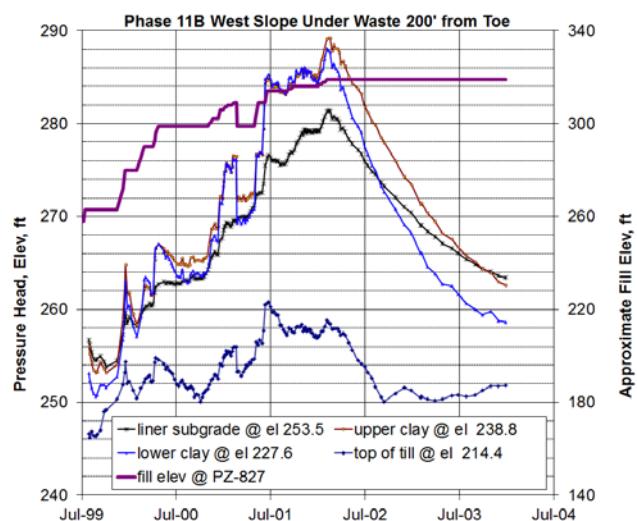
Figure 9 – PZ 827 pore pressures and waste elevation about 200 ft away from PZ 819

Figure 9 illustrates the timing of waste placement next to the berm at this location. The initial response to his question was that the pore pressure increase was probably due to horizontal compressive stress on the clays under the berm due to waste loading placed next to the berm. This response was adequate for the time being, however, his question raised other questions, such as, if there is pore pressure buildup, and then dissipation, how much shear strength would be gained under the berm due to that consolidation process? And why did the pore pressures increase in the deeper clays when there was little horizontal movement at that level?

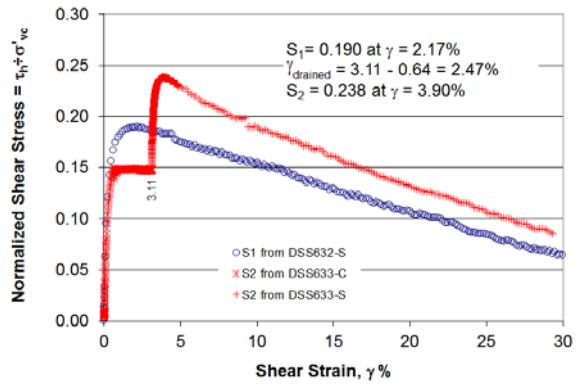
Figure 10 – Stress-strain curves from one and two-stage DSS tests with results of stage 1 in blue and stage 1-2 in red. S_1 and S_2 are the peak normalized shear stresses.

Figure 10 shows typical stress-strain curves from the one and two-stage DSS tests that were run. The single stage test (blue data) indicated that the undrained strength ratio (S_1) of the specimen would be approximately 0.19. The initial stage of the two-stage test (red data) was run with a shear stress ratio of 0.15, which corresponds to a strength to stress ratio (factor of safety) of 1.26.

After the constant stress and zero pore pressure waiting period shown in Figures 10 and 11 (where the stress ratio was held at 0.15), new shear stresses were applied until the specimen failed, not at an undrained strength ratio of 0.19 as it would have in a single stage test, but at a ratio of 0.238. This represented a strength gain of approximately 25% due to the application of the drained shear stresses.

Reynolds and Germaine (2007) provide many more details of the multi-stage DSS testing. Briefly, Figure 10 shows the results of a set of multi-stage DSS tests where the ratio of shear stress to shear strength during the drained strain period was 0.15 (the consolidation stress, σ_{vc} , was constant throughout the set of tests). In this test, the drained strain was 2.47%.

At Crossroads, whereas a limit (Red Alert) of 0.25% strain in two weeks was set for the initial stage of waste placement in a landfill cell, it was reduced by two-thirds to 0.083% in two weeks for the subsequent stages. The two-thirds reduction factor came from the average ratio of strain to failure in the second stage DSS tests. For example, for the clay in Figure 10, the reduction factor was $(3.90\% - 3.11\%) \div 2.17\% = 0.36$

It should be noted that the stress-strain curves for the remolded clays do not demonstrate the characteristics of a strain-softening soil the way the virgin clays do. Figure 10 illustrates how peak shear strength is developed at a fairly low strain and then the strength drops off after that. The stress-strain curve from testing remolded, reconsolidated clay tends to follow the same curve of the virgin clay up to near the peak on the virgin clay curve and then continues to rise, i.e. the clay becomes strain hardening.

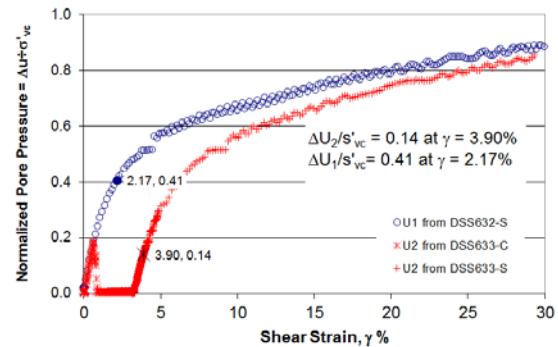
Figure 11 – Pore pressure curves from one and two-stage DSS tests with results of stage 1 in blue and stage 1-2 in red. See Attachment A for enlarged versions of Figures 10 -11.

As shown by the red data points in Figure 11, after the specimen was stressed to a shear stress ratio of 0.15, it was allowed to undergo drained strain. This is typically what happens during the landfill waste placement, where a stage of waste is placed and then remains at that elevation for some time while drained strain of the clay takes place.

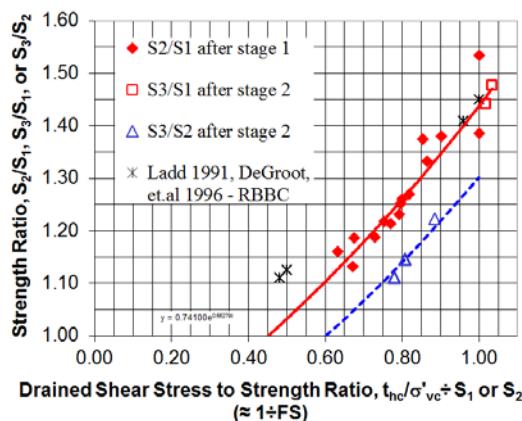
Figure 12 – Recommended plots for determining shear induced strength gain (SISGa). Red and blue data points for Presumpscot Formation, black asterisks for Resedimented Boston Blue Clay. See Attachment A for an enlarged version of Figure 12.

Figure 12 graphically shows the results of the 16 sets of multi-stage DSS tests that have been run. In these tests, it was found that the amount of drained strain did not influence the SISGa, whereas the shear stress to shear strength ratio did have a significant effect on the SISGa. In other words, the closer the clay gets to failing in the initial loading, the stronger it is after the pore pressures from shearing dissipate. This is the same trend that DeGroot, et. al. (1996) found for the Boston Blue Clay. In addition, Professor Charles C Ladd, in his 1986 Terzaghi Lecture also briefly mentioned SISGa and found the same trend (Ladd, 1991).

Figure 12 primarily summarizes the results of tests that were run the same way as those illustrated by the data on Figures 10 and 11. That is, the two- and three-stage tests were run on intact clay samples that were initially subjected to drained shear and then undrained shearing to failure.

Figure 12 also includes two data points that are plotted higher than a strength ratio of 1.00 in red squares with no in-fill. As the legend indicates, these points came from the results of a three-stage DSS test, where the strength from the shearing to failure was divided by the shear strength from a single loading stage test (S_3/S_1).

While Ladd asked how we came up with Figure 12, we asked what he thought the reasons for SISGa were. We explained that we had tried to use sampling and CRSC testing to confirm an increase in the preconsolidation pressure of the clay after it had undergone drained shear in the field, but consolidation tests rarely would indicate the level of strength gain that we found in the two-stage DSS tests. Ladd's explanation was quite simple. The strength gain comes from both an increase in the preconsolidation pressure and a change in the direction of the principal stresses in the clay when it is sheared. Thus you should not expect to be able to attribute more than about 50% of the SISGa to a change in the preconsolidation pressures measured by the CRSC tests.

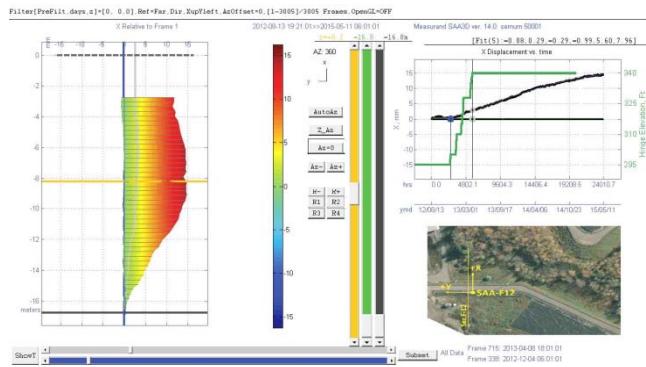
Figure 13 – Graphical results for inclinometer SAA-F12 showing displacement vs. depth on left plot and displacement and waste elevations vs. time on right plot.

Figure 13 shows the results of fixed inclinometer data recently collected during waste placement on a critical cross section.

Of particular interest in Figure 13 are the deflection vs. time and waste elevation plots at the upper right of the figure.

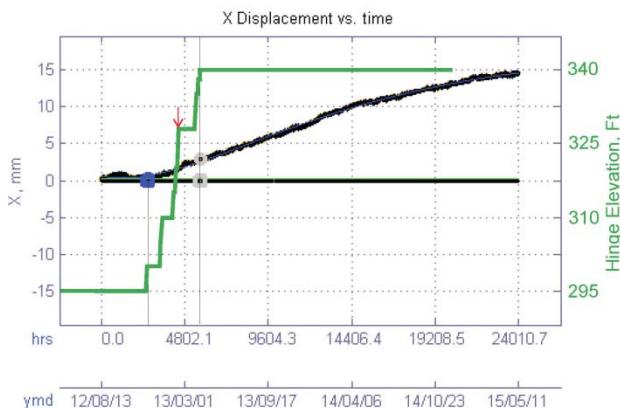
Figure 14 – Blowup of displacement and hinge elevation vs. time plot from Figure 13

Figure 14 provides a blow-up of the portion of Figure 13 showing the displacement and waste elevation plots. Note on Figure 14 that starting about 5 days before 2013-03-01, precisely 25 February 2013, the waste hinge was raised from Elevation 310 ft to 327 ft.

In a relatively short time span, the waste hinge had been raised, first to El 300, then after waiting a few days it was raised to El 310. Each time the hinge was raised, the displacement rate remained fairly constant. Then when the hinge was raised

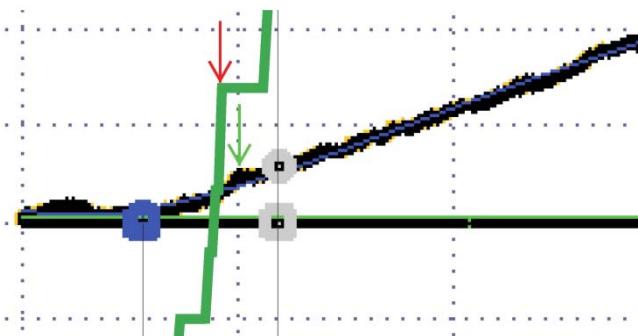
Figure 15 – Further blow up of the displacement and hinge elevation vs. time plot from Figure 13 showing the discrete data points and the displacement rate leveling off on about 1 Mar 2013 (green arrow).

to El 327, the rate increased. (See Figure 15) The high resolution of the plot (i.e. the high frequency of the readings) permitted us to see the rates soon after the waste was placed.

The question was, did this increase in the displacement rate indicate that a longer waiting period should be used? Figure 15 helped to readily answer that question.

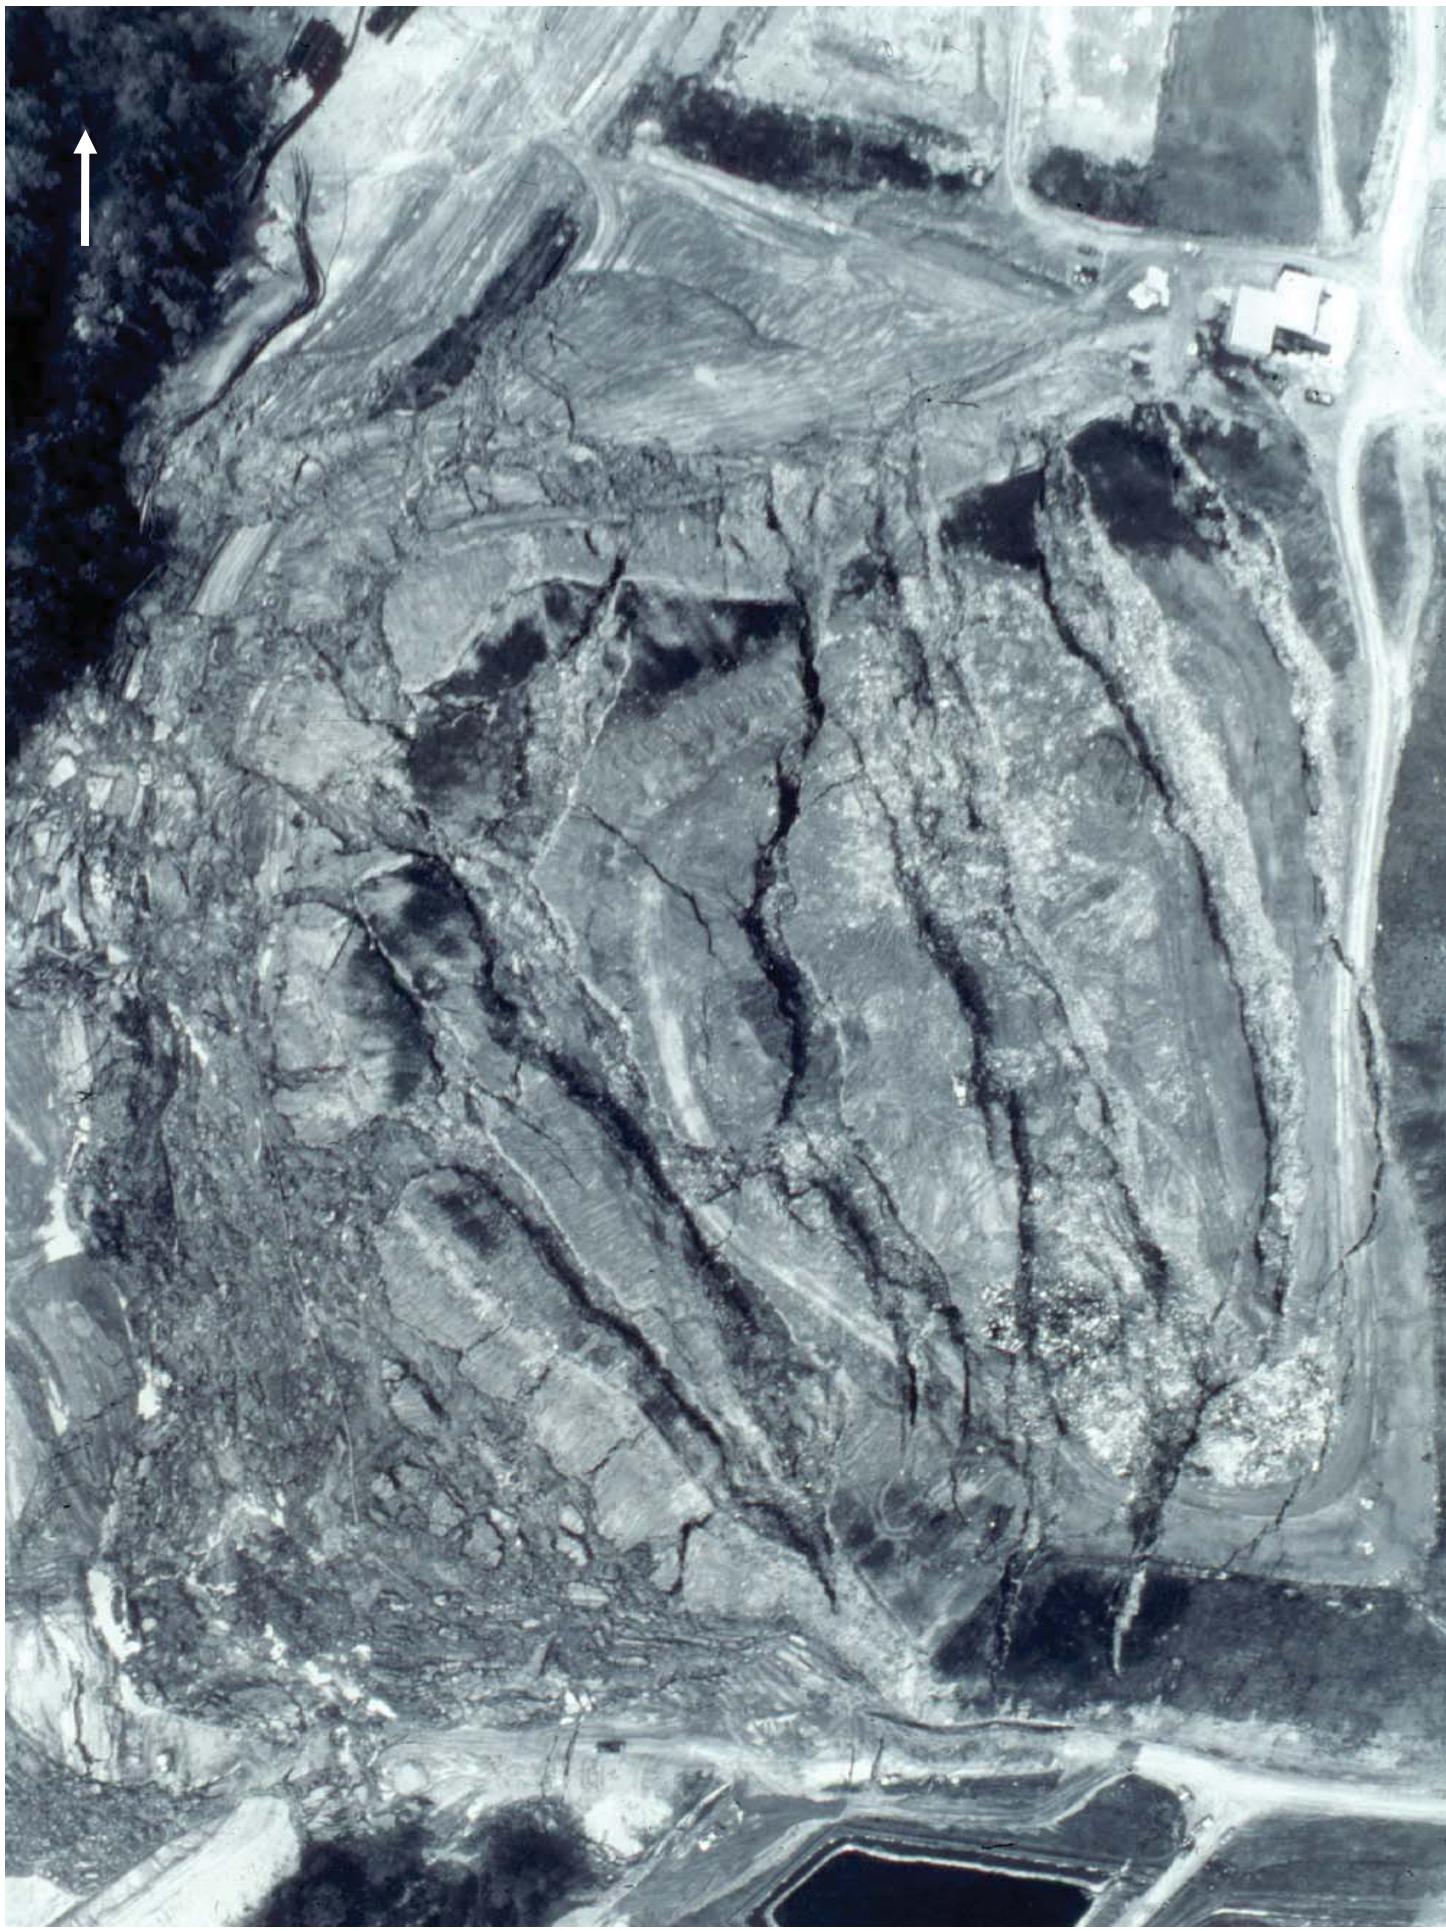
Air Photo of August 1989 Landslide at Crossroads Landfill. North-South distance of photo is approximately 1500 feet.

Investigations to pin-point the cause of the 1989 landslide concluded that the slide was likely triggered by sloughing of clay into the drainage trench next to the existing waste pile. The sloughed clay left a somewhat higher and steeper unsupported slope, which quickly slid onto the area where the olive-brown clay had been excavated. This in turn left an even higher unsupported slope, which also failed. By the time the retrogressive sliding stopped, one could clearly see 6 distinct blocks of waste from the former waste pile, "floating" on a base of remolded soft gray clay. In front of the 6 blocks was a wide debris field of waste mixed with remolded clay. Attachment A contains an air photo taken just after the landslide.

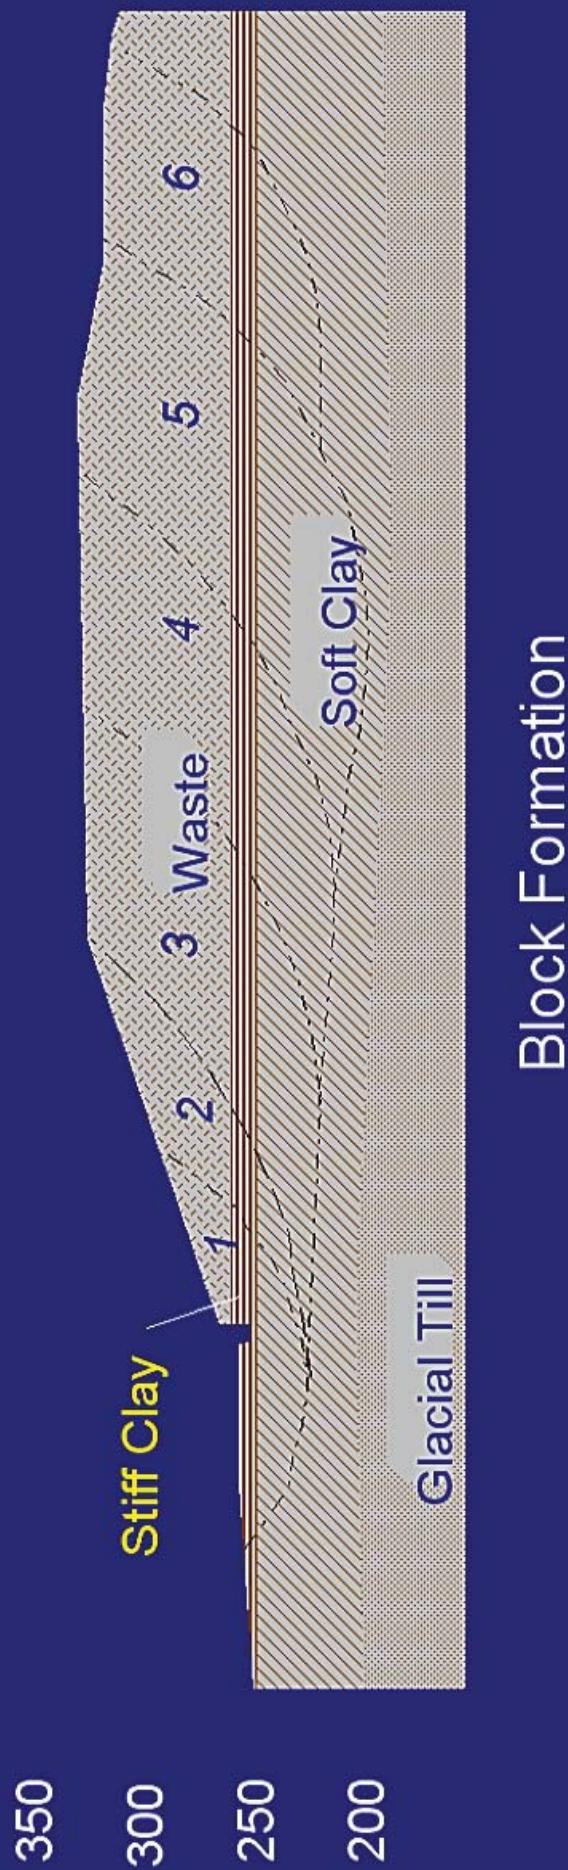
Figure 2 - MSW waste and clay blocks before breaking apart in the 1989 MSW Landslide.

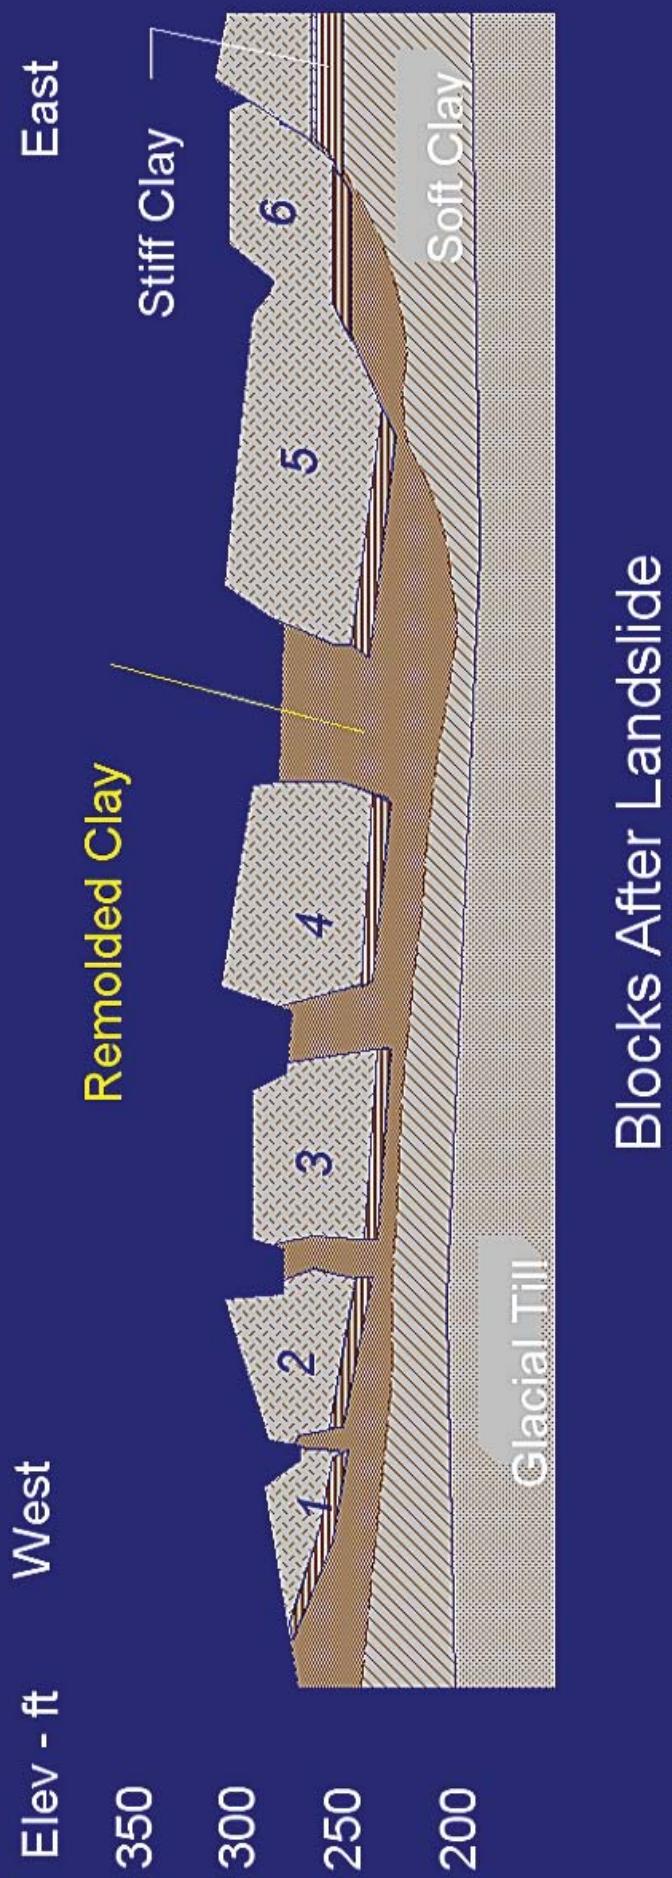
Figure 3 - MSW waste blocks "floating" in remolded and intact Presumpscot clay after 1989 MSW Landslide

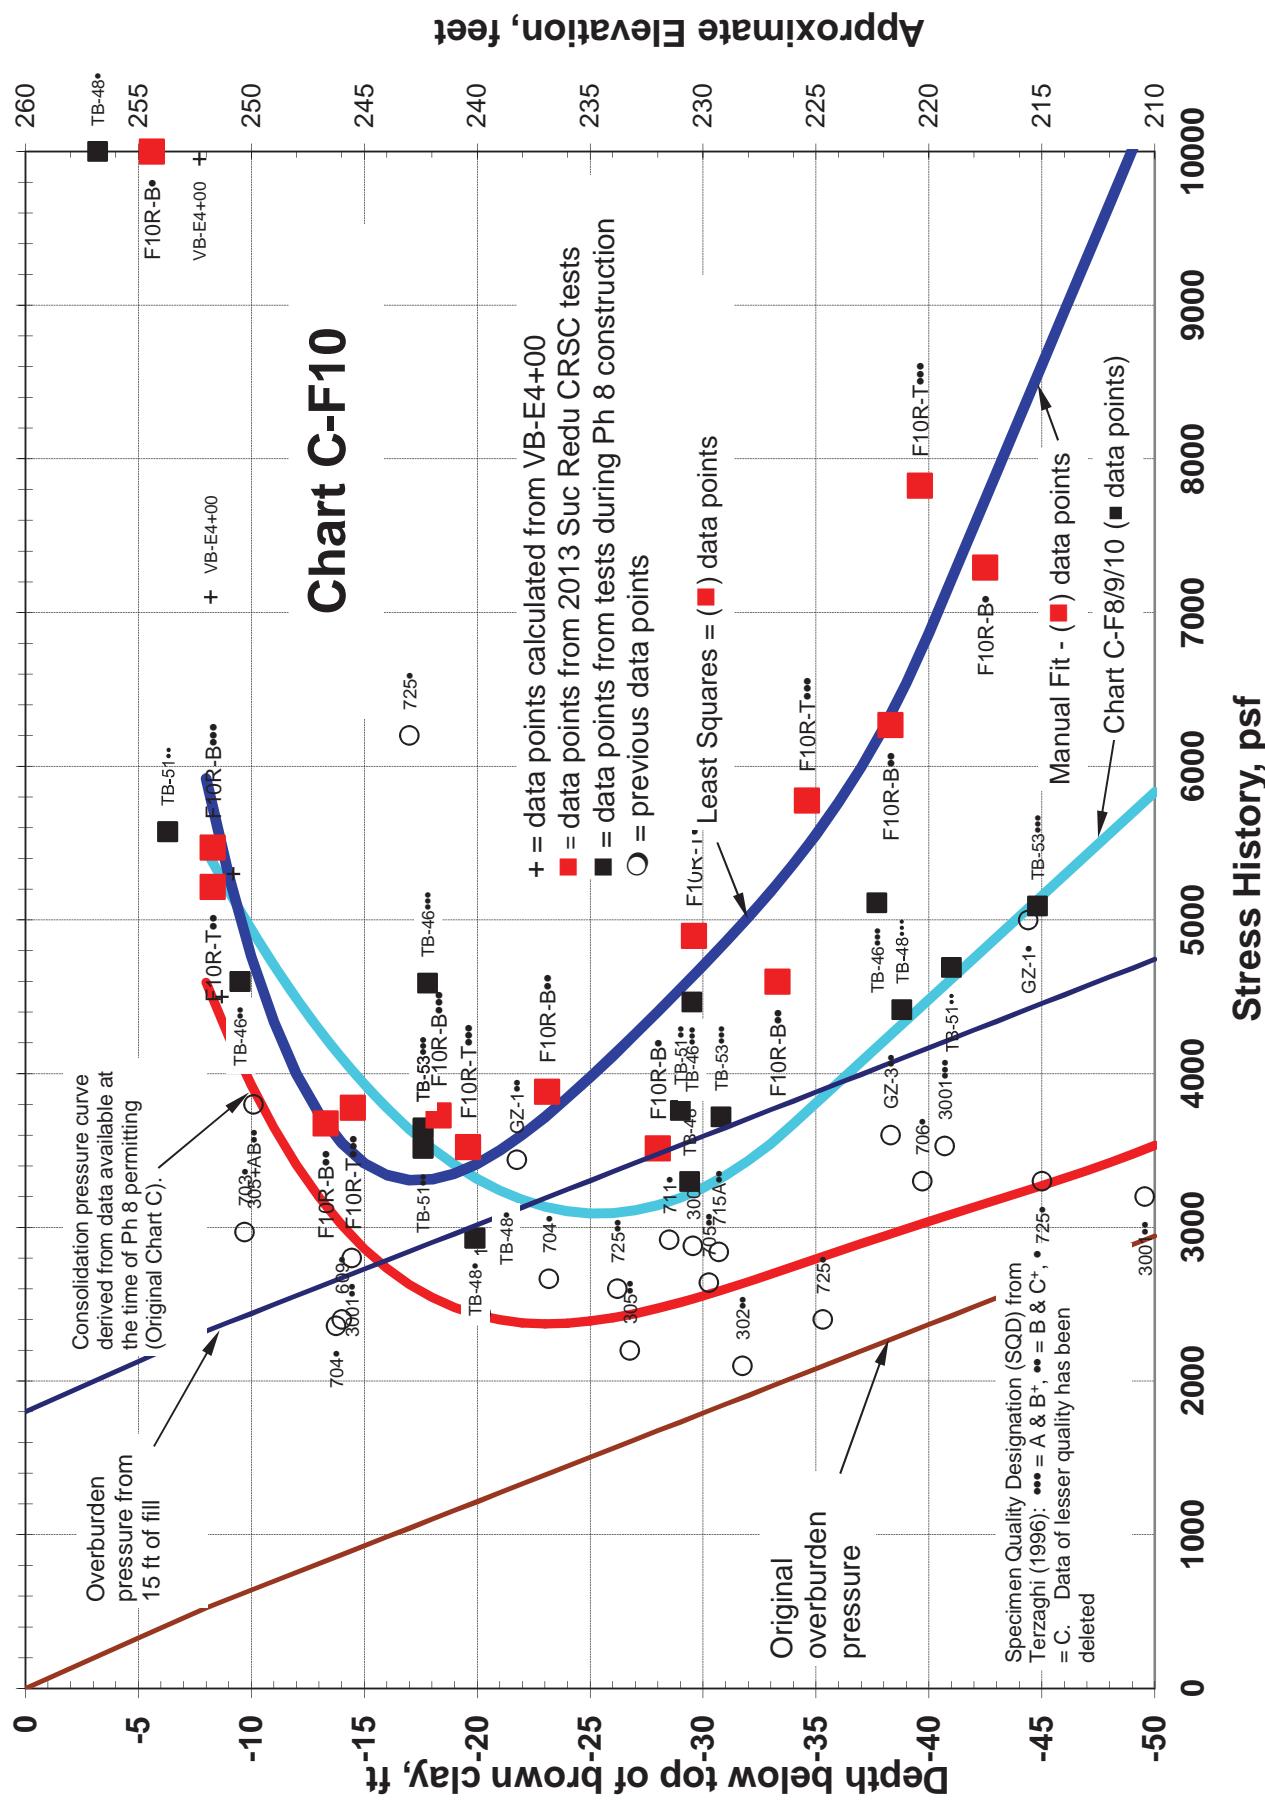
Figure 7 - Stress history or preconsolidation stresses vs. depth for specimen obtained before 1998 (red curve), between 2000 and 2005 (light blue curve) and in 2013 (dark blue curve).

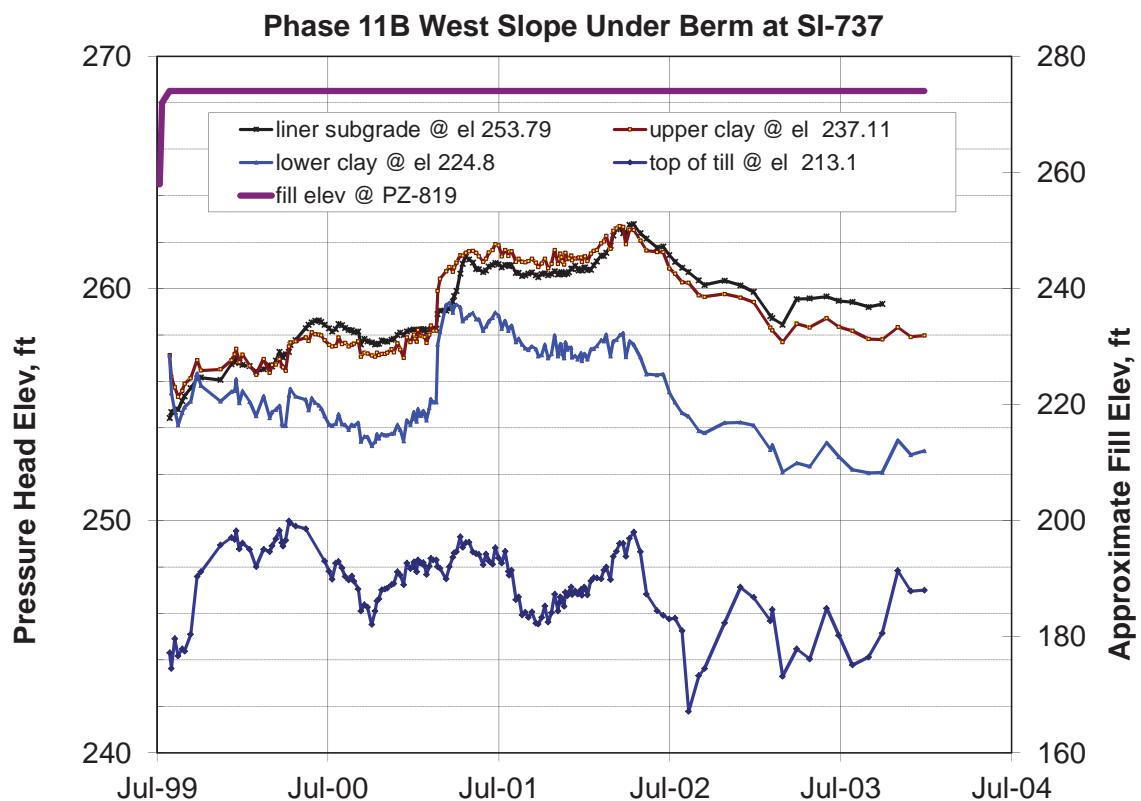
Figure 8 - PZ 819 located under stability berm at the toe of the waste slope

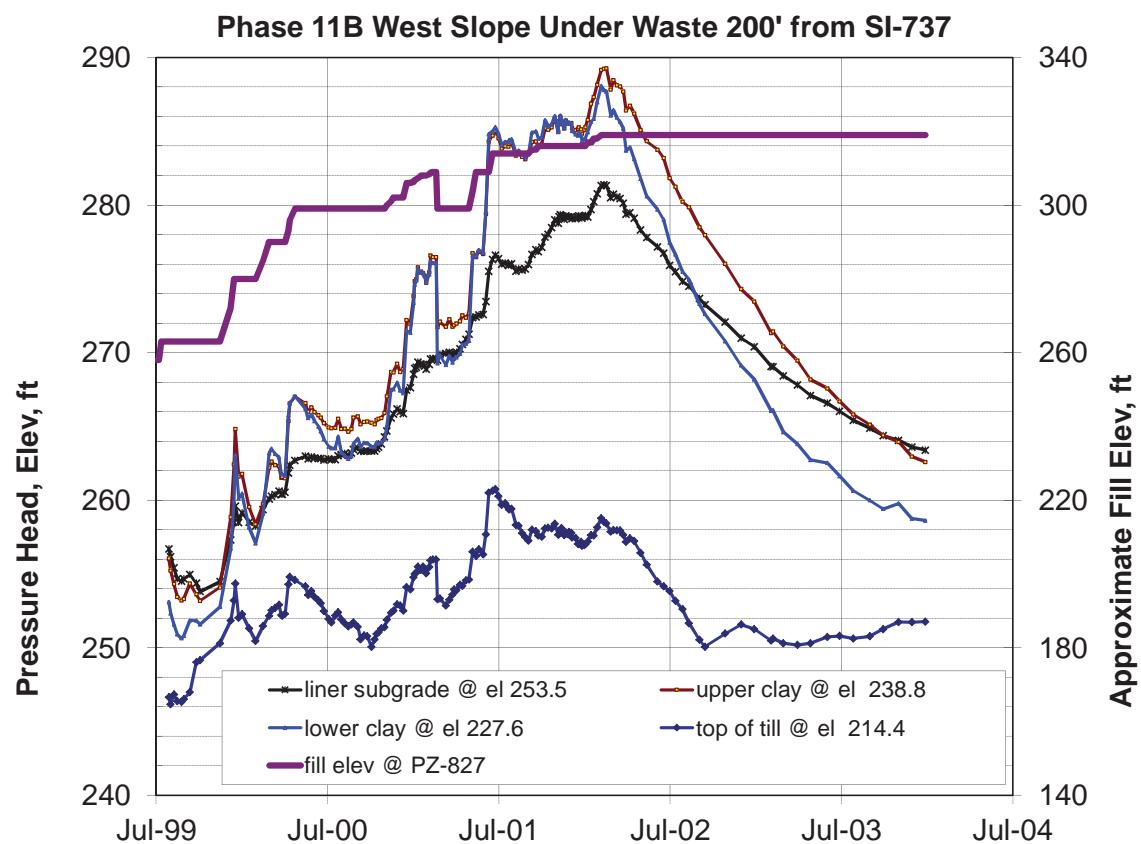
Figure 9 - PZ 827 pore pressures and waste elevations 200 ft away from PZ-819

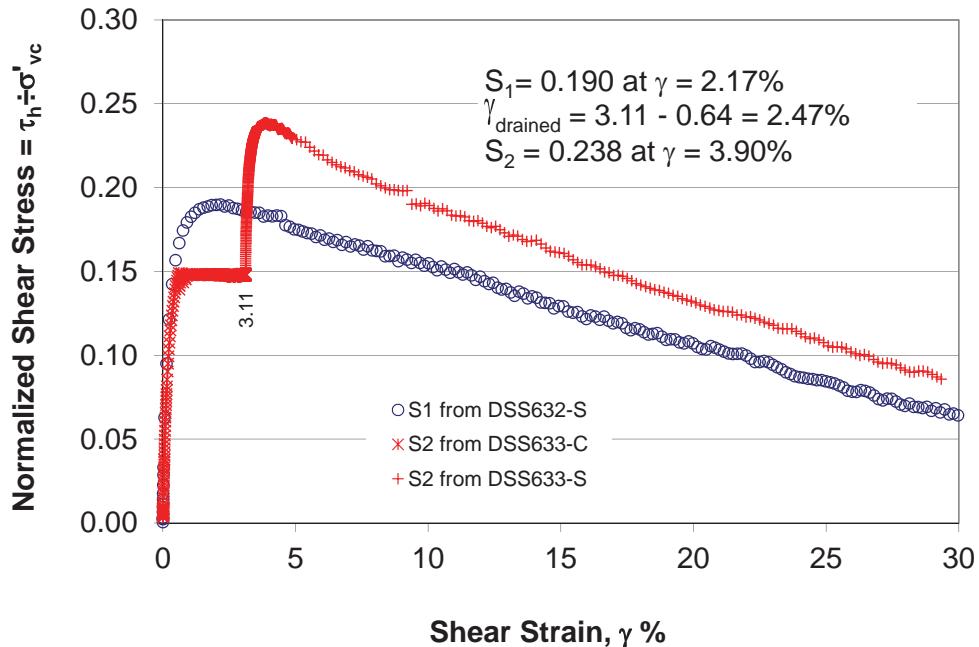
Figure 10 - Stress-strain curves from one and two-stage DSS tests with results of Stage 1 in blue circles and Stage 1-2 in red plus signs. S_1 and S_2 are the peak normalized shear stresses.

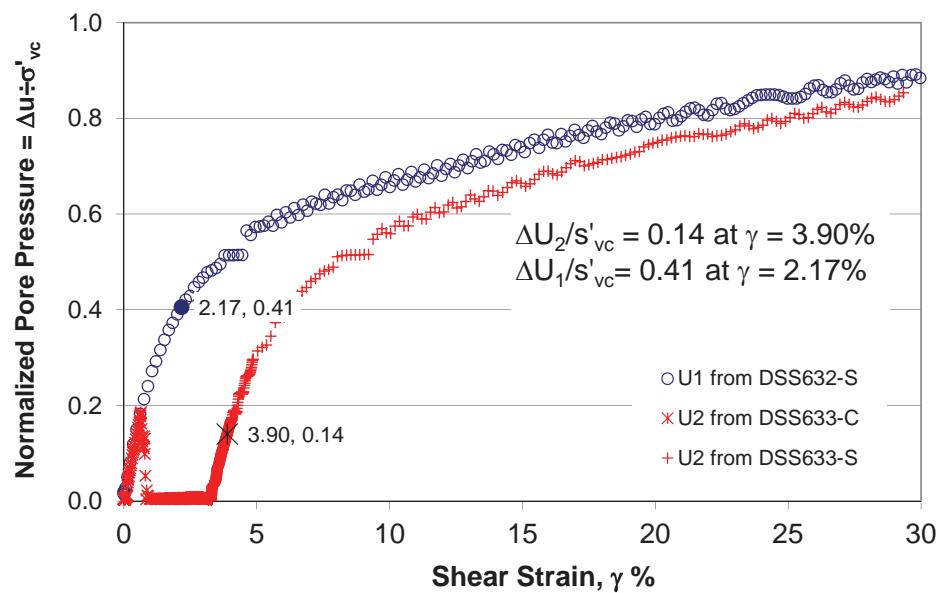
Figure 11 - Pore pressure curves from one and two-stage DSS tests with results of Stage 1 in blue circles and Stage 1-2 in red plus signs.

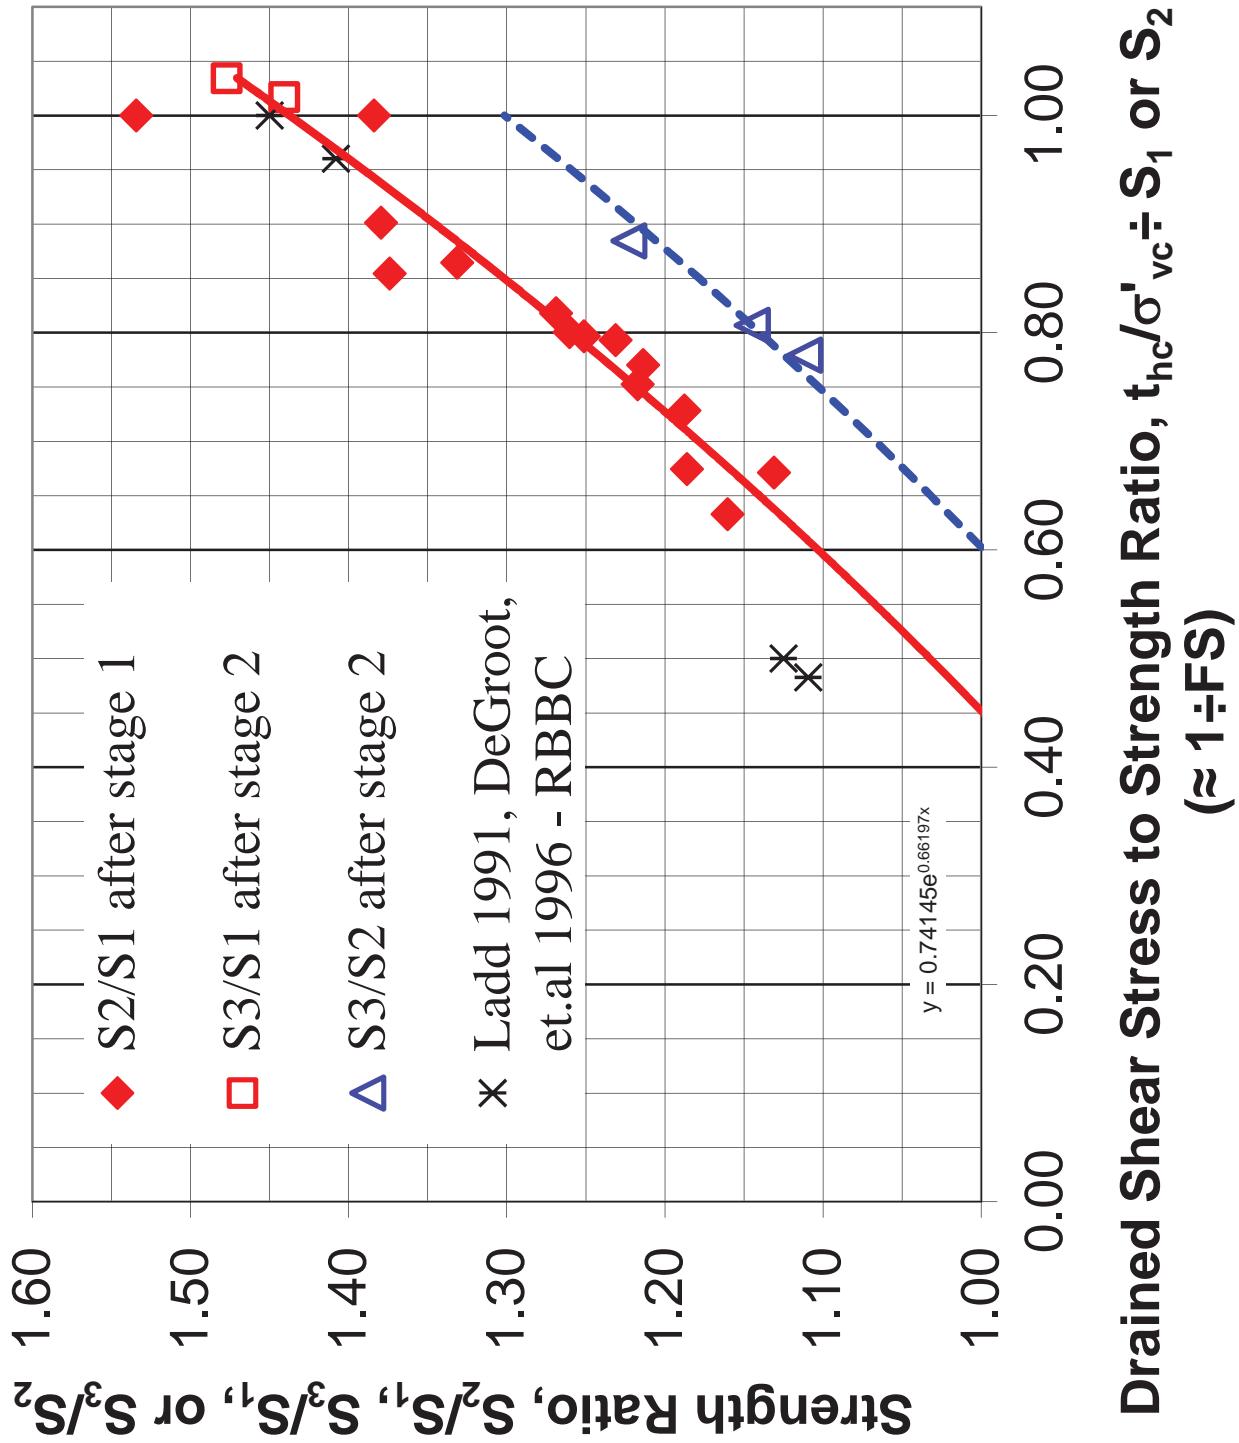
Figure 12 - Recommended plots for determining shear induced strength gain (SISGa). Red diamonds and squares and blue triangles for Presumpscot Formation, Black asterisks for residimented Boston Blue clay.
