# Morro Bay Volunteer Monitoring Program

## Eelgrass Monitoring

Winter 2009

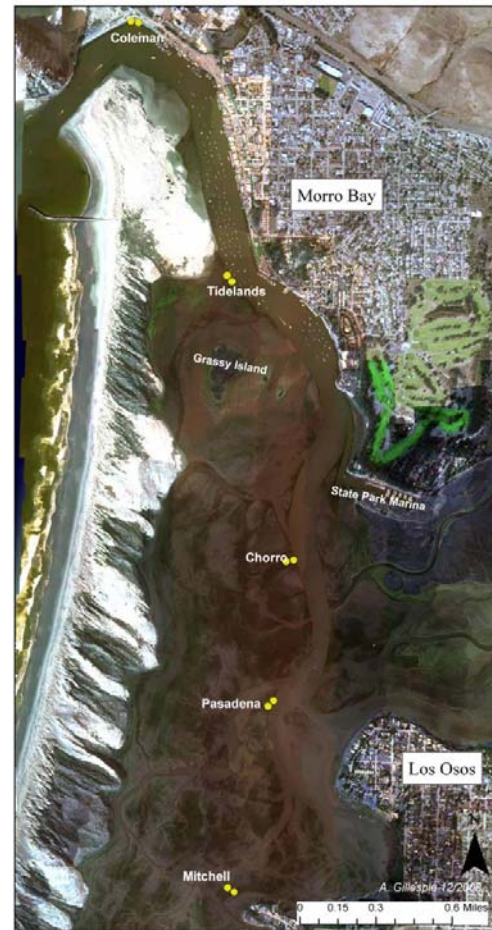
### Where We Monitor

Four permanent transects were established throughout the bay in the spring of 2005. At each transect, shoots were collected for biomass measurements, and the density of shoots were counted. These transects were selected to represent different zones within the bay and to capture differences be-

The Coleman, Tidelands, Chorro and Pasadena transects were monitored in 2008.

Monitoring at the Mitchell transect was suspended in 2007 due to safety concerns and the sensitivity of the remaining eelgrass in that area. The Coleman transect was established in 2006 to increase the spatial scope of monitoring in Morro Bay.

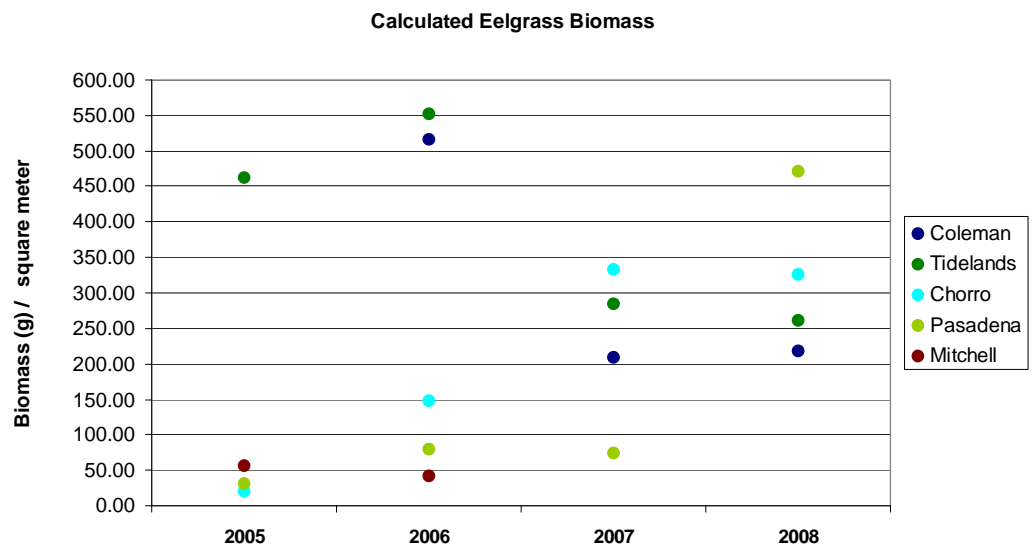
Biomass amounts have varied widely between sites and over a period of four years. In 2008, both back bay sites (Pasadena and Chorro) yielded greater biomass than the front bay sites. Although Pasadena demonstrated a dramatic increase in biomass between 2007 and 2008, biomass at the three other transect sites remained relatively stable.

At the lab, shoots are carefully cleaned to remove all mud and debris. Shoots are wrapped in pre-weighed foil and dried in an oven for several days. Once fully dried, the shoots are weighed again to determine their mass. At each site the average mass for a single eelgrass shoot is calculated. This average weight can be multiplied by the number of shoots counted in a quadrat to determine the amount of eelgrass in a square meter.

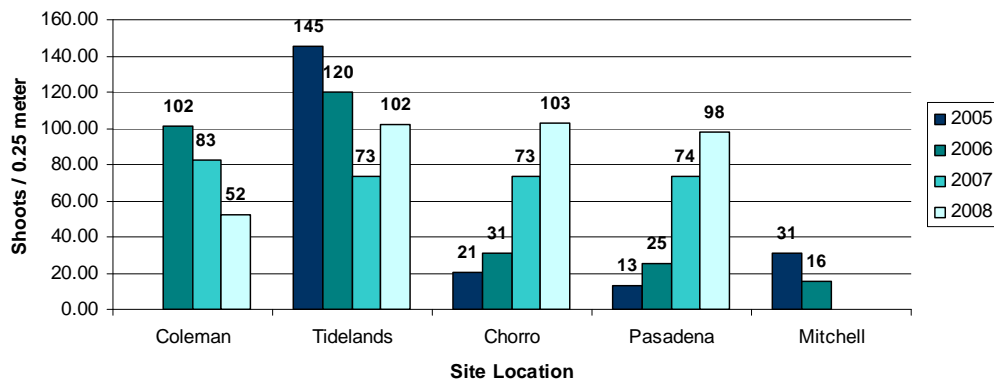
Mean Eelgrass Shoot Density

Shoot densities have consistently increased at the Pasadena and Chorro transects over the last four years. The mean percent cover of eelgrass has also increased significantly at both of these sites. Mapping from aerial photographs has confirmed these findings and indicated that eelgrass beds are increasing in size in this area of the bay.

The Tidelands transect demonstrated a slight recovery in 2008 following two years of declining densi-

ties, and a dramatic decline in percent coverage in 2007. In most cases, a decline in coverage is matched by a decline in shoot density. The data collected from the Tidelands transect in 2006 is an exception to this trend. This may be the result of very large shoots, which provide more coverage than a high density of shorter shoots with few leaves.

Monitoring over a four-year period has helped characterize habitat trends in different regions of Morro Bay. The data collected from each of these transects provides an indication of the health of eelgrass beds in the surrounding area. While shoot densities have declined in some areas, they have risen in others.

The data collected from each of the 20 quadrats is combined to calculate an average shoot density and percent cover of eelgrass for each transect.

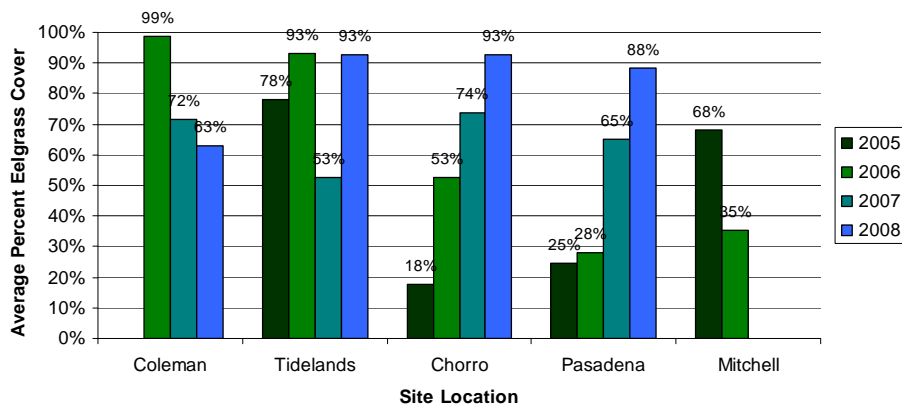
Eelgrass Percent Cover

Shoot densities have consistently increased at the Pasadena and Chorro transects over the last four years. The mean percent cover of eelgrass has also increased significantly at both of these sites. Mapping from aerial photographs has confirmed these findings and indicated that eelgrass beds are increasing in size in this area of the bay.

The northernmost transect in Morro Bay (at Coleman Beach) has shown declines in both eelgrass shoot density and percent cover. The eelgrass at this beach is subjected to the most recreational and industrial impact of the four transects. Year-round traffic from beachgoers and the proximity of urban and commercial activities may be contributing to the decline of shoot density and coverage.
