Opening a Can of Worms: *Septic System Inspections and Biomat Evaluations in the Georges Pond Watershed*

Maine Sustainability & Water Conference
March 30, 2023

Presenters:
Jennifer Jespersen, Ecological Instincts
David Rocque, Consulting Soil Scientist & Site Evaluator

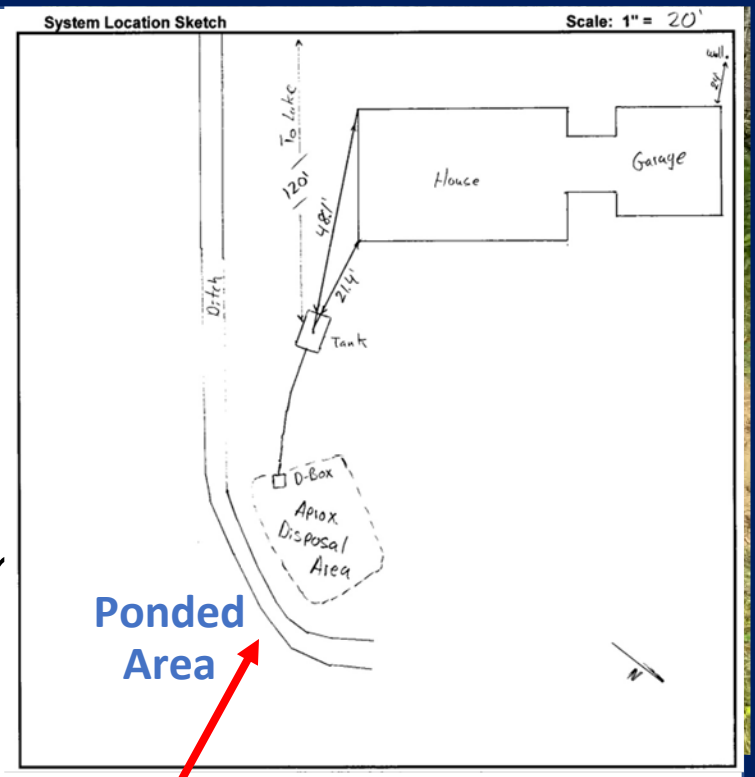
System # 5

- **Year-round** home on the lake
- Post-1974 Septic System
- No HHE-200 record on file
- Concrete tank in good working order

- Installed in a natural drainageway
- Ponded area upslope of disposal field
- Excavated drainage swale adjacent to disposal field to drain to ponded area (evidence of ponded water)
- Natural drainage swale in woods connects excavated drainage swale to lake

- One of the disposal field pipes located in gravel a couple of feet from excavated ditch
- Bottom of stone in disposal field lower in elevation than bottom of excavated drainage ditch

Direct connection to the lake

Would likely have surfacing effluent if not for the connection to the ditch

- Disposal field is a **significant threat** to the lake- Highest Priority
- Replace as soon as possible
